Summary of our work at Peckfield Landfill Site

Peckfield Landfill

Summary of site activity and regulation, May 2013 – August 2014.

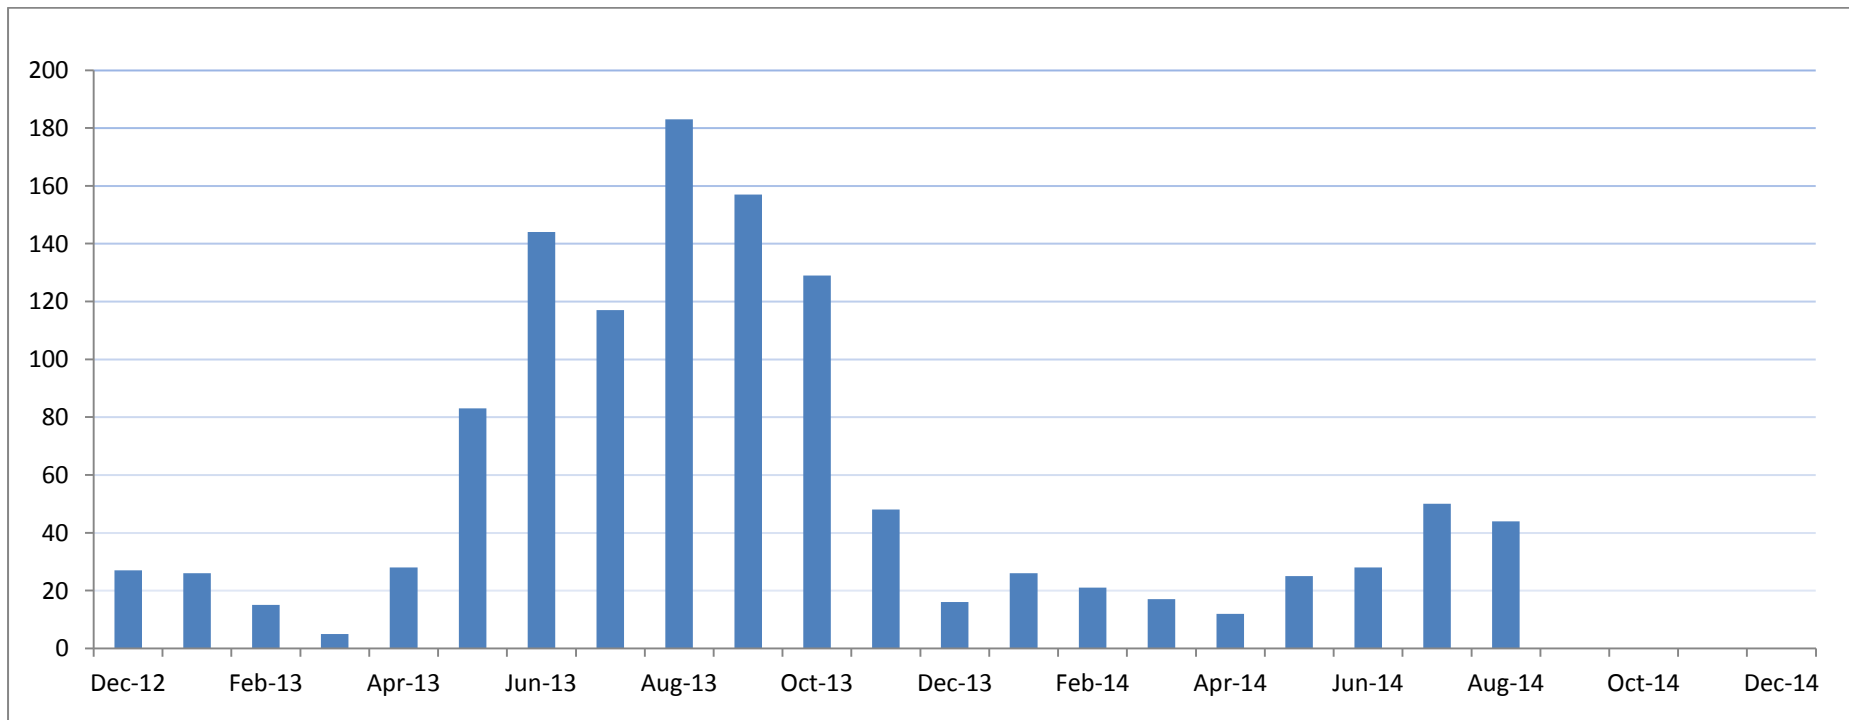
Odour reports by month: 3 Dec 2012 - 22nd August 2014
