John Smeaton Leisure Centre Swimming Pool

Site inspections undertaken on 20th March 2014.

MAIN SWIMMING POOL

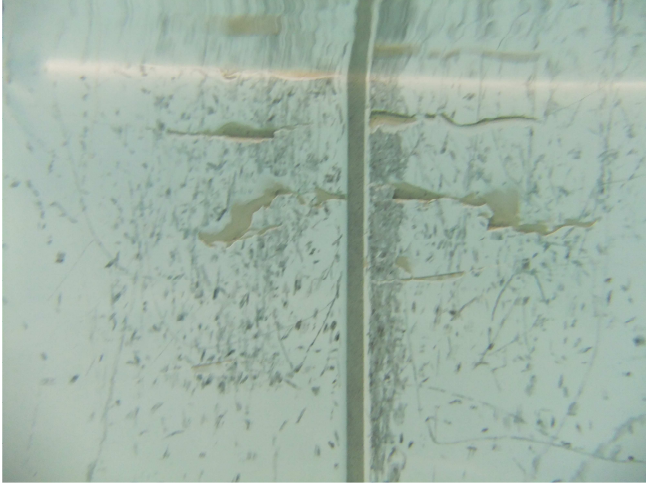
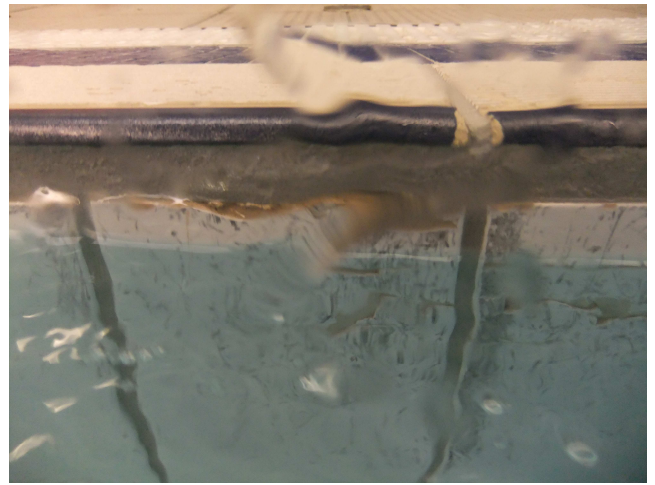
Damaged tiles taking place to the base of the swimming pool shallow end entry step unit.

Item 16- Damage to swimming pool longitudinal side wall – shallow end entry steps.

Damaged tiles taking place to the swimming pool shallow end entry step:-

With reference to this item, the damage is being caused as a result of the step units being placed in and out of the swimming pool tank. A HDP (High Density Polyethylene) striker plate could be fixed which would prevent further damage to the tile face.

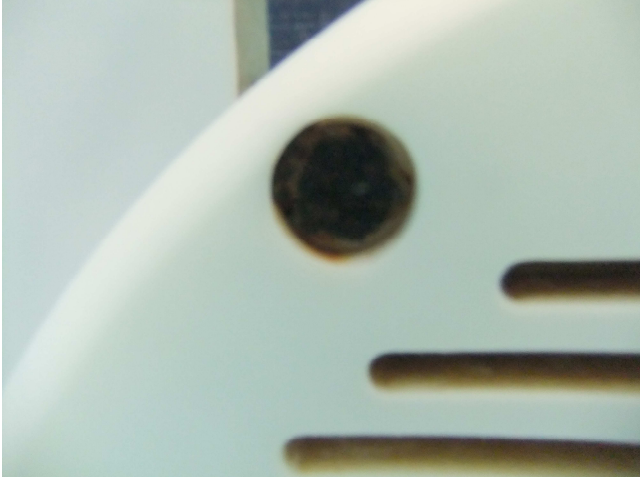
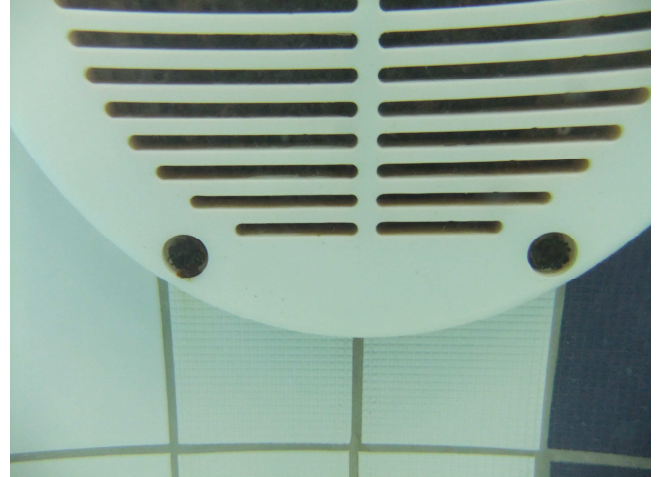
All existing fixings within the swimming pool circulation inlet grids- corroded.

Item 17- All swimming pool circulation inlet grid fixings- corroded.

All existing swimming pool circulation inlet grid fixings- corroded:-

With reference to this item, we would recommend that these fixings be replaced utilising 316 stainless steel fixings to prevent possible insecurity of the units.

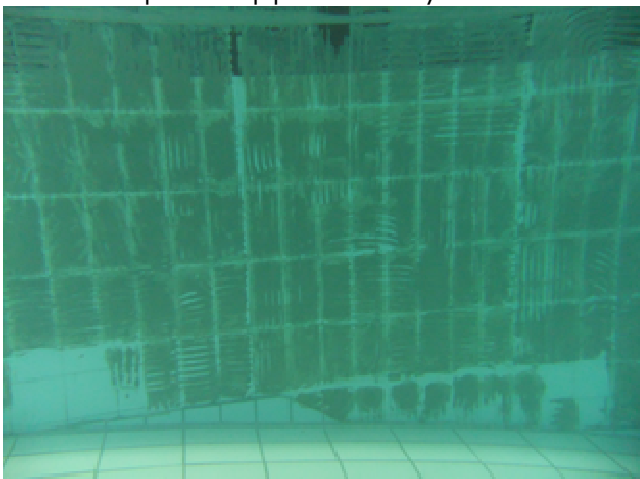
Exposed background of area of defective wall tiles – area of tile removed and HDP (High Density Polyethylene) panels position in place with 316 stainless steel fixings.

Area of repair is approximately 16m².

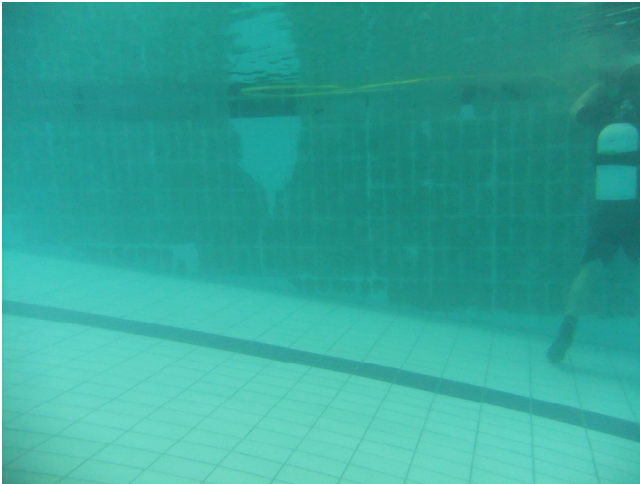
Upon removal of tiles, background identifies that a hairline crack is taking place to the wall which may have been a long term hairline crack as we cannot establish how long that has been evident.

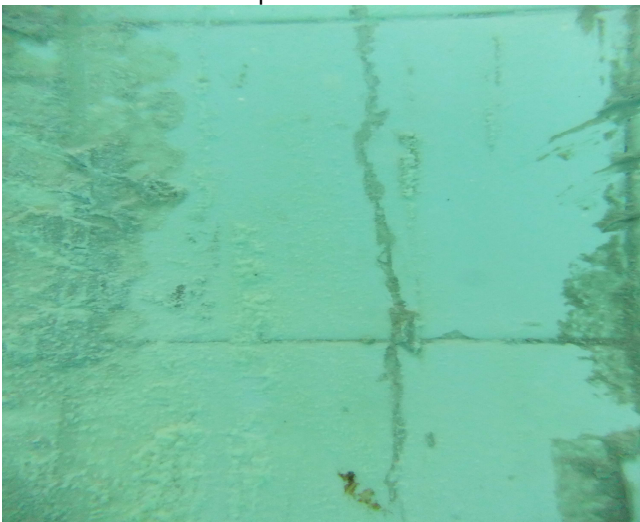
We also identified that there was a hairline crack within the location of an area which had not shown signs of preparation similar to the newly exposed as there was no signs of adhesive adhesion once exposed.

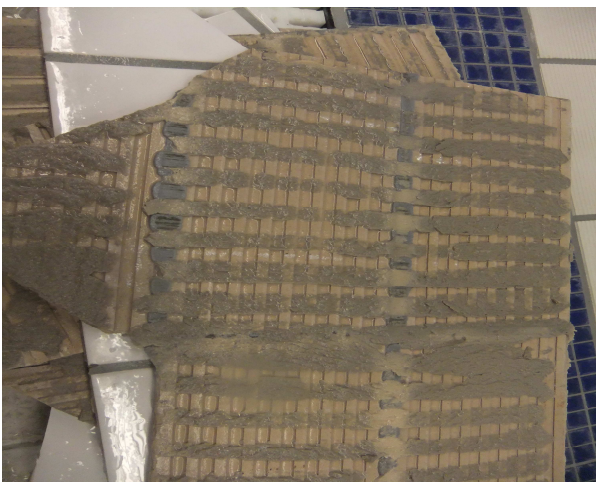
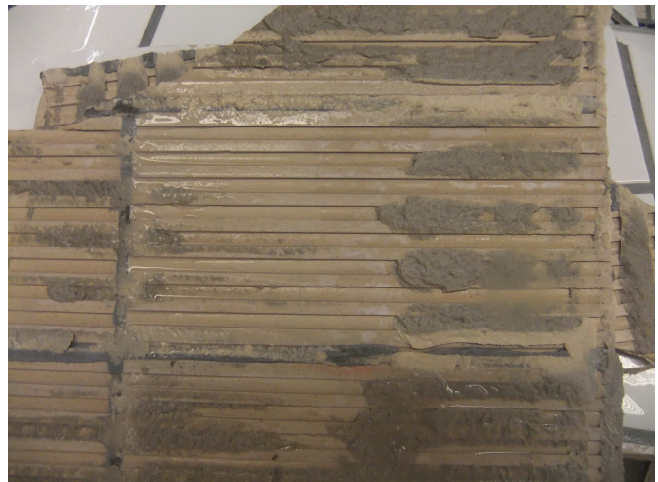
Upon removal of the tiles the evidence was that the tiles had not been solid bed fixed as per the BS Guidelines.
