Leeds City Council **West Park Community Centre** Condition Survey Review Desk Study and Visual Survey

Issue 2 | 26 November 2012

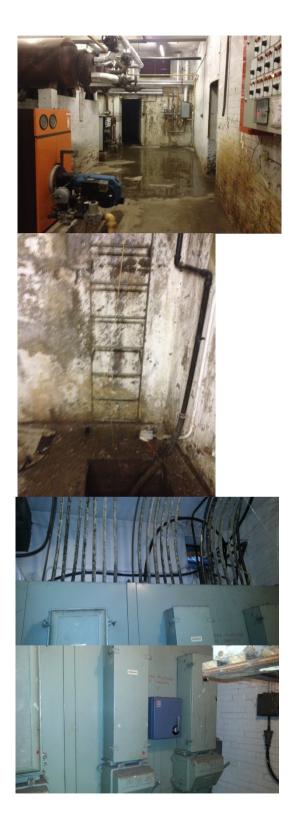
Plant Basement

The main incoming switchgear serving the building is located within the plant room (B/251). The existing switchgear has exceeded its expected life and is in poor condition. The switchroom where the switchgear is located within close proximity to a water leak – tide marks were found on switchboards.

Significant water ingress to plant room and electrical switch room

It is recommended to replace main incoming switchgear and rewire all lighting and power services. Provide new sub-distribution boards with miniature circuit breakers and residual current devices protection, in accordance with BS 7671. Wiring should be tested & inspected at intervals not exceeding 5 years.

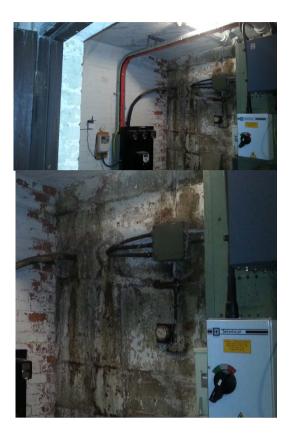
Plant Room

Location of main incoming supplies and metering.

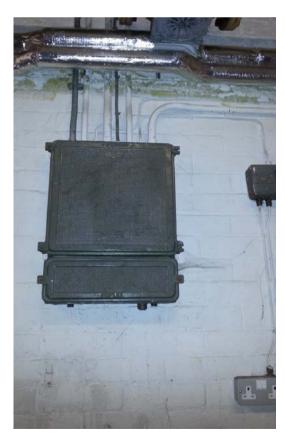
Plant Room

Example to age and condition of switchgear within the plant room.

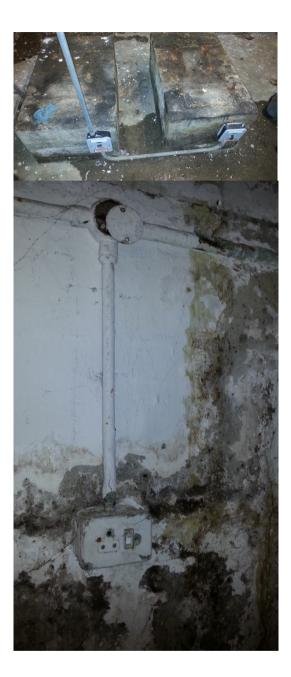
Plant Room

Three phase isolators / switch disconnectors close proximity to water ingress.

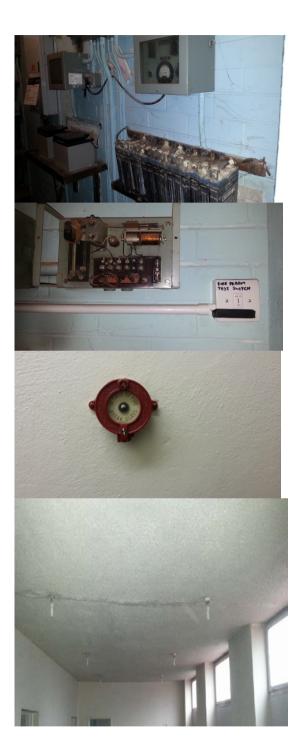
Fire Alarm Control System

A manual mains only (240V) non-addressable fire alarm system is currently in place wired using a mixture of mineral insulated and soft skinned fire alarm cables. Our findings indicate the existing fire alarm system does not comply with BS 5839 and is in very poor condition.

Evidence to show condition of stand by batteries used to serve fire alarm system.

It is recommended to strip out and replace the current fire alarm system with an addressable automatic fire alarm system in accordance with BS 5839. Category of

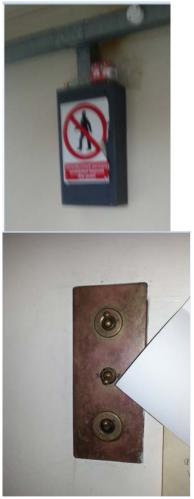
Luminaires throughout the building generally consist of linear fluorescent tubes (T8 - T12) and tungsten lamps. The lighting system has not been rewired since the building was constructed and currently does not conform to BS 7671. Lighting to the building is in generally poor condition and inefficient.

Example of light switch currently in use. Indicated rewire of lighting system has not taken place.

Rewire and replace all luminaires throughout the building in accordance with BS 7671. Lighting should be designed for the purpose of each room.

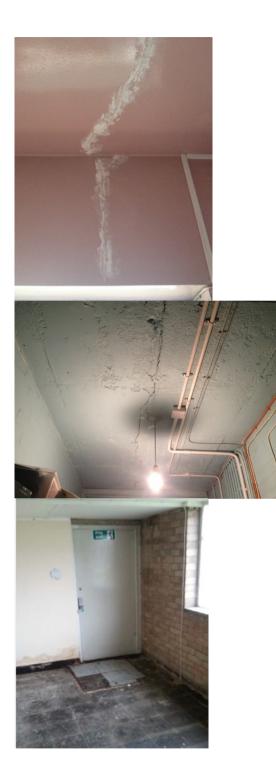
Office areas G224-232. Example of cracking to soffit with evidence of potential continuing movement.

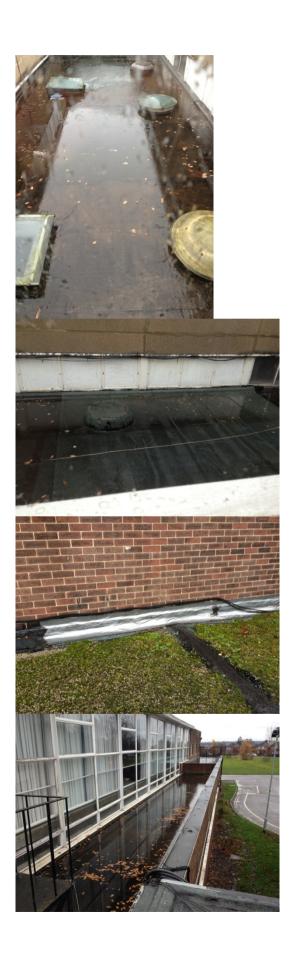
There are significant areas of ponding to roof areas and, whilst various patch repairs have been made, improving the leakage issues reported in 2009 there will have been further degradation over time of flat roof systems. In addition the movement notable in a number of ceilings will be indicative of strains within the flat roof system and the likelihood of continuing issues with the flat roof areas.

Ponding to flat roof area 15.

Ad Hoc Repairs to Roof material, roof area 15.

Ad Hoc Repairs to Roof material on roof area 2.

Significant ponding to flat roof area 3.

Patch repairs have been carried out, but extensive roof refurbishment is considered to be required to many areas to prevent the on-going cycle of leaks and patch repairs.

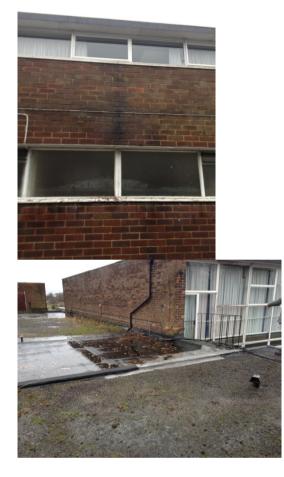
Leakage through brickwork due to ponding on roof area 3.

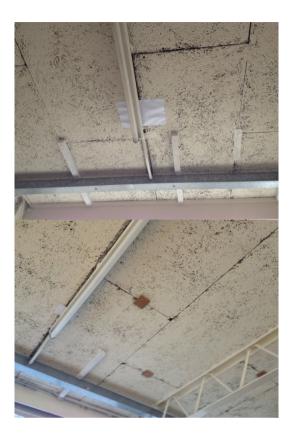
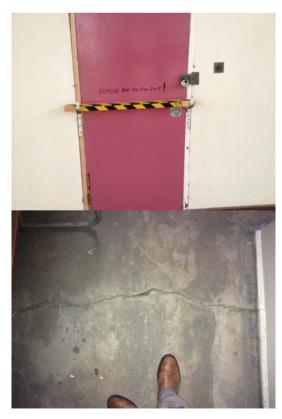
There are many areas of ceilings in a state of disrepair and with water damage throughout the building, in addition issues have now been reported with ingress of bats and with woodwool ceiling panels coming loose and fallings.

Remedial measures to prevent bat ingress through building fabric rood area 17.

Remedial works to prevent woodwool slabs coming loose and falling on soffit of roof area 17.

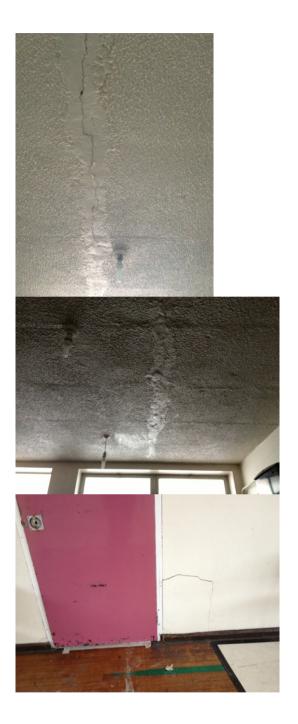
Cracking to underside of 1st floor (taken from ground floor) showing evidence of possible continuing movement. Evidence in rooms G/061, G/062, G/065, G/066.

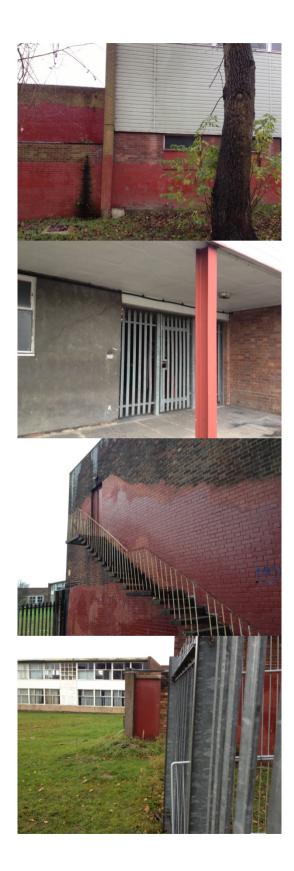
Cracking to the Northern Ballet block and the kitchen block has not been remedied, it is likely that these have deteriorated since 2009, but without a monitoring regime, or any indication that prior attempts at repair would give, this cannot be ascertained definitely.

Significant settlement cracking to Northern Ballet SE gable corner of elevations E40 and E41.

Cracking to wall adjacent to elevation E43, potentially linked to gable end settlement.

Poor condition of fire escape on elevation E36.

Obstructions to fire escape remain at Elevation E36.

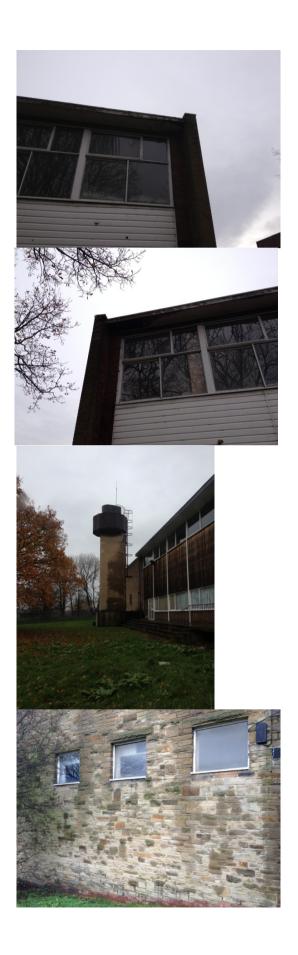
Soffit and cladding degradation to elevation E37.

Spauling and degradation to water tower, section loss and exposed rebar. Elevation E6.

Cracking to Ashlar wall. Potentially settlement.

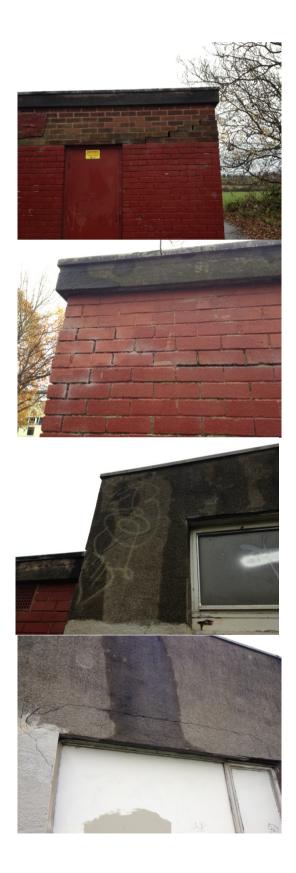
Settlement cracking to corner of old kitchen block. Elevation E18.

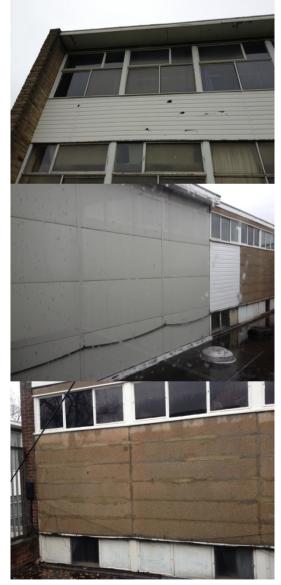
Settlement cracking to corner of elevation E20.

Deterioration and damage to cladding and soffits elevation E24.
