Re: Bridgewater Place Tower - On-Site Verification of Wind Microclimate Conditions

RWDI 1900495

BWP – FINAL SUMMARY

03/10/2019 rev04 Final

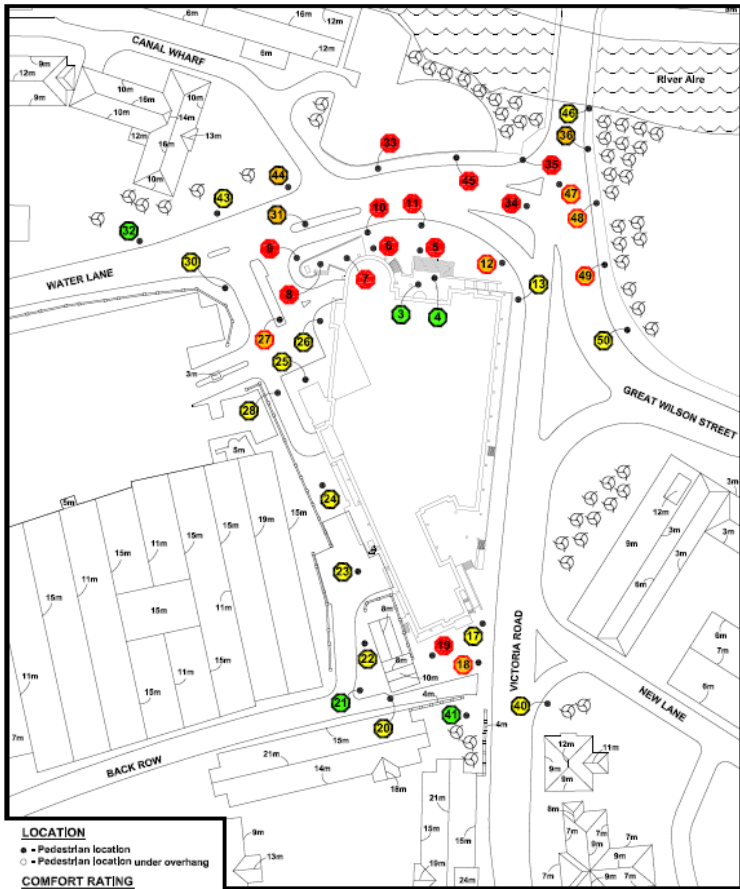
Wind tunnel test no mitigation scheme

- Of the [90] points that were tested in the wind tunnel, 35 failed the Lawson safety criteria at 15 m/s.
- The next slide shows all the points that were tested in the wind tunnel. There are 2 plans showing the original test points and additional test points.

- The Lawson failures are the points that have a red outline to them. Points with a black outline are a pass.
- The failures are concentrated at the front of the property but there are a small number of failure points to the rear.

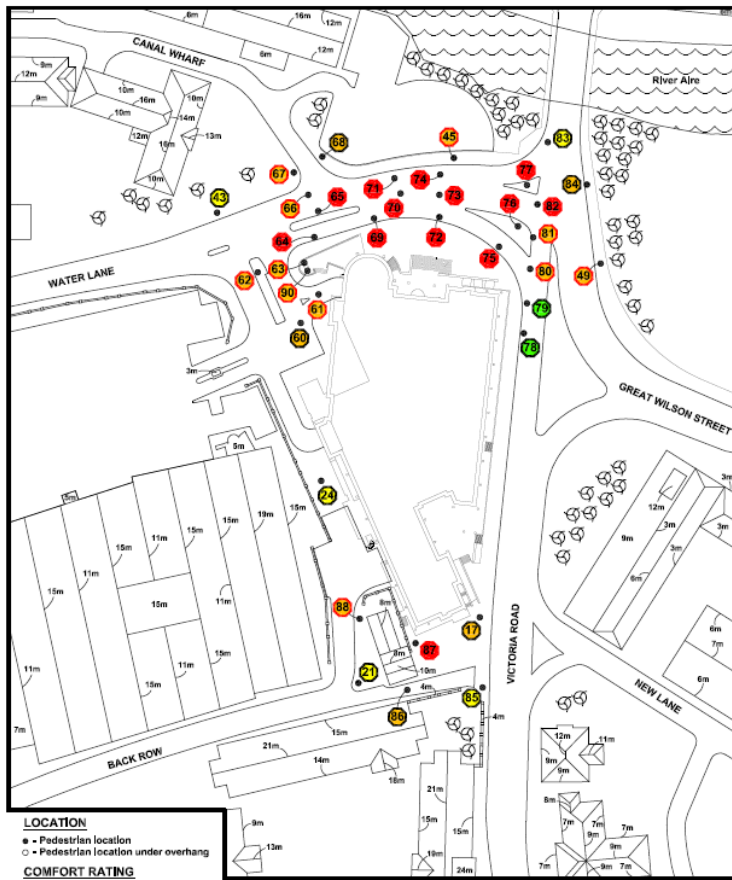
● Points 17, 21, 24, 43, 45, 49, 60-68, 80
 ○ All points located at ground level

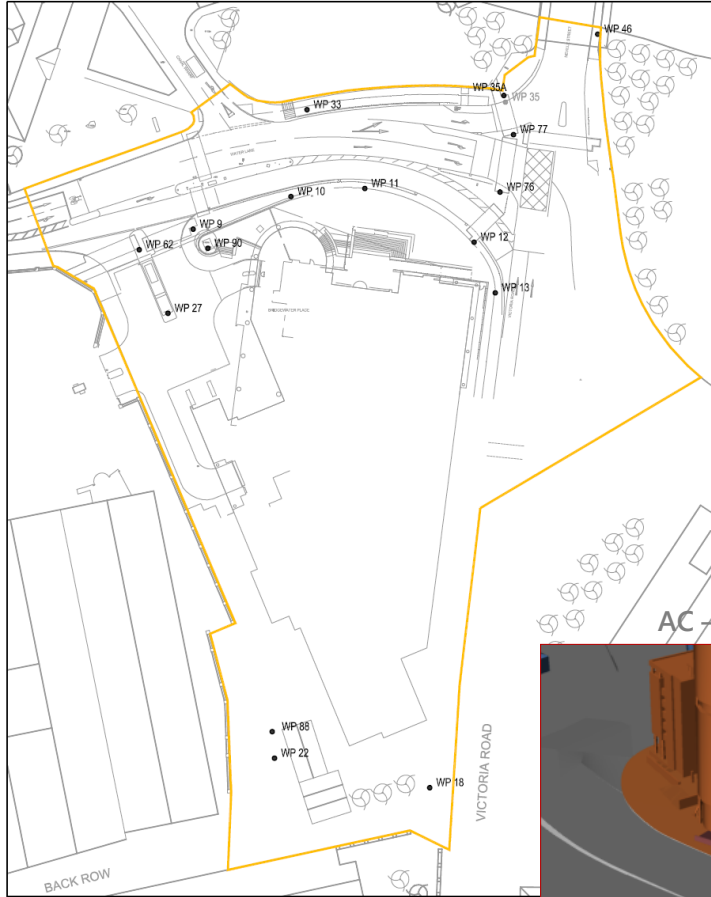
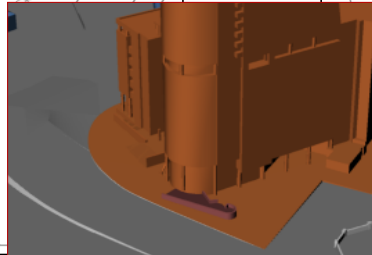
WIND MONITORING POINTS - EXISTING ROAD LAYOUT

- The next slide shows the 16 test points (for the existing and new road layout). They were selected as the best representative points from the failure points identified in the wind tunnel and CFD results (noting that it was not possible to have test points in the middle of the road).

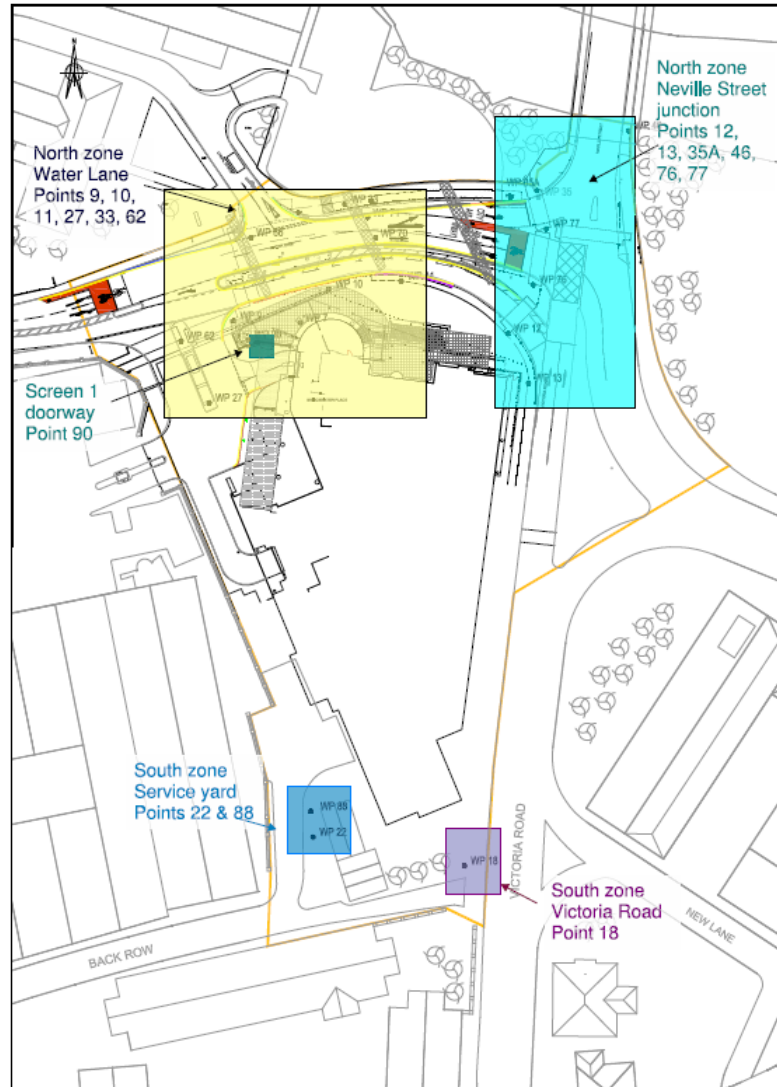
GROUPED POINTS

BuroHappold grouped the monitor points into 4 zones (see next slide).

- This shows that at the front of the building there are no Lawson failures at 15 m/s.
- This is a better position than that predicted by both the wind tunnel and the CFD analysis.
- There are 2 points which failed the Lawson safety criteria (at 15 m/s):
 - Wind point 88 – Service Yard;
 - Wind Point 18 – Courtyard at rear of Bridgewater Place.
- In addition, CFD analysis showed a possible marginal failure on Back Row by the Grove Inn. This point was not tested (but is being tested).

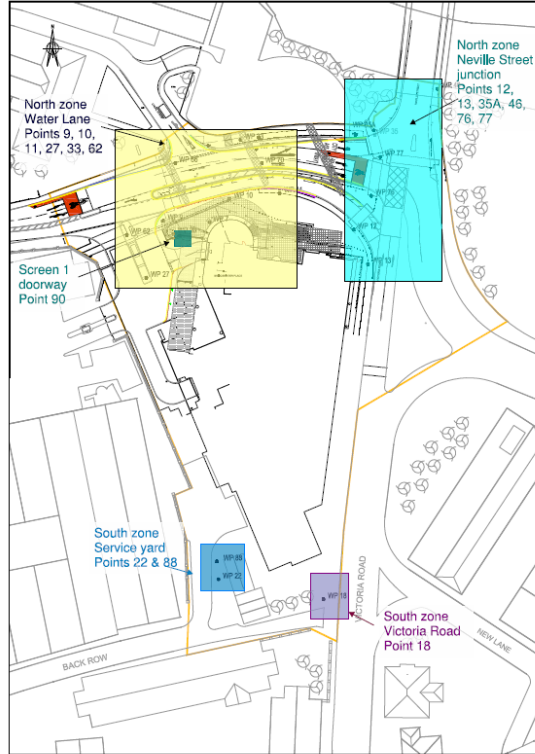
OVERVIEW

- We have reduced the wind speeds significantly along Neville street, below the pre mitigated BWP levels. The NE corner has lower wind speeds across the road.
- Along Water Lane we have reduced wind speeds significantly. The wind speeds are similar to those of the baseline, except at two locations under the baffles.
- We are experiencing wind acceleration at the south of the building that affects Victoria Road. Half the area across Victoria road is better than the baseline because the shelter provided by the building itself.
- We have a zone of wind acceleration at the south. The south zone "service yard" is a restricted area and traffic is not likely to travel fast here.

The next slides show the number of hours over both 15 m/s (Lawson safety for frail/elderly) and 20 m/s (Lawson safety for able-bodied) against the 2 hour threshold.

It also shows the wind test failure points at 15 m/s (none of the points failed at 20 m/s).
