West Park Community Centre

Full/Partial Demolition of West Park
Community Centre – Feasibility
Study

ISSUE | 9 April 2013

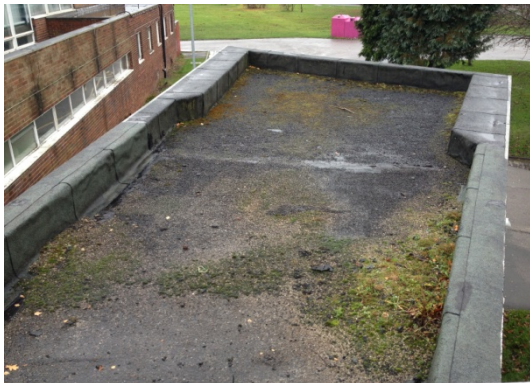
There are significant areas of ponding to roof areas to be retained, particularly so adjacent to the entrance area as indicated in the condition review report where water is building up behind the masonry parapet and leaking through the parapet brickwork. Various patch repairs have been made, improving the leakage issues reported in 2009 however there will have been further degradation over time of flat roof systems and on-going patch repair can be expected if the roof is not recovered. In addition the movement notable in a number of ceilings will be indicative of strains within the flat roof system and the likelihood of continuing issues with the flat roof areas. It is not considered essential to re-roof the building to bring it back into operation, however it does constitute an on-going maintenance and potential property damage issue.

Debris and flat roof condition to entrance canopy roof area 1.

Debris and vegetation should be removed from roof areas generally.

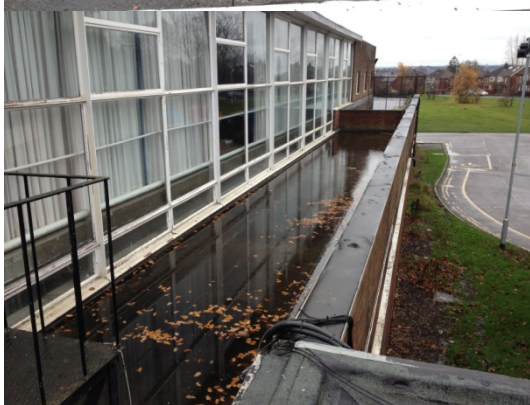
Significant ponding to flat roof area 3.

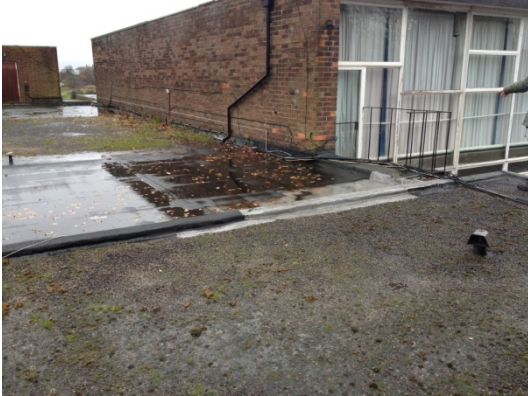
Roof Patch Repairs, roof area 3.

It should be noted that if over 50% of a roof requires repair then, in accordance with the Part L2B document (where thermal element is a subject to renovation and its renovation is technically and economically feasible), the performance of the whole element should be improved to achieve or better the relevant U-Value standards as set out within the document.

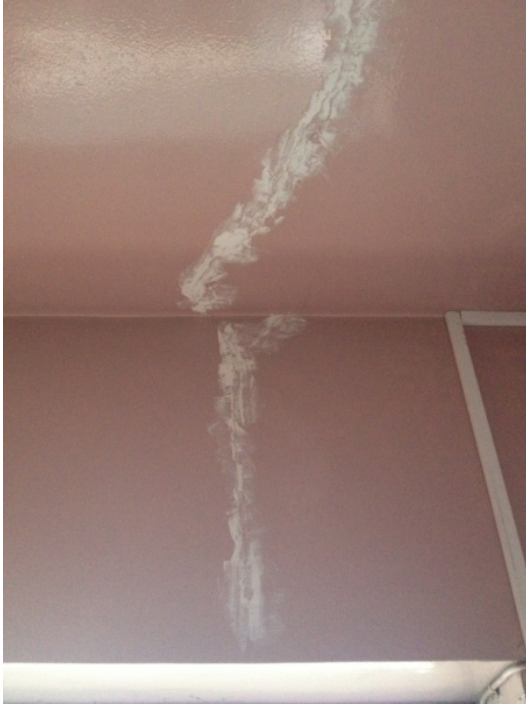
Office areas G224-232. Example of cracking to soffit with evidence of potential continuing movement.

Monitoring of external wall cracking and cracks within ceilings is recommended. These may require further investigation and remedial action if continuing movement is proven.

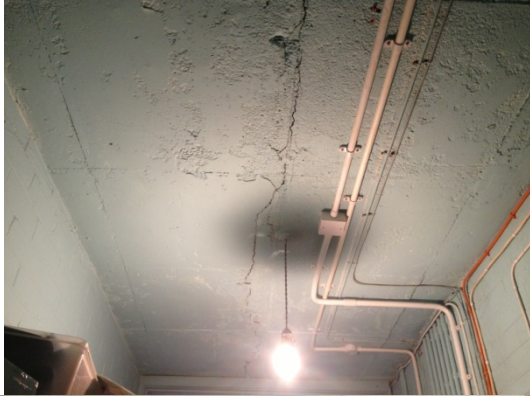
Office areas G224-232. Example of cracking to soffit with evidence of potential continuing movement.

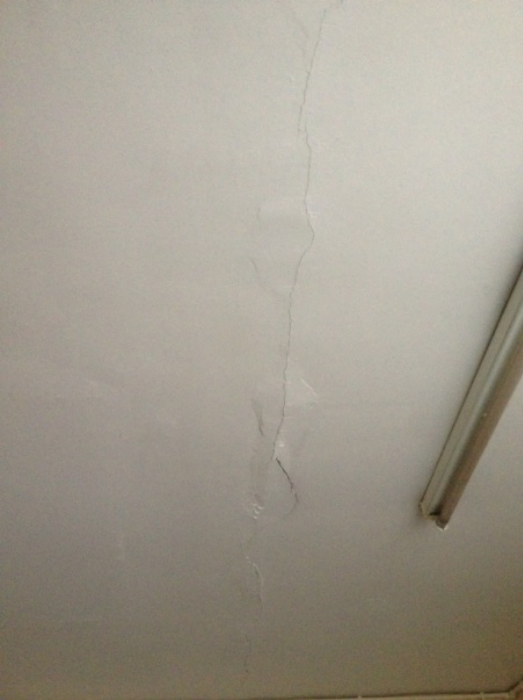
Office areas G224-232. Example of cracking to soffit with evidence of potential continuing movement.

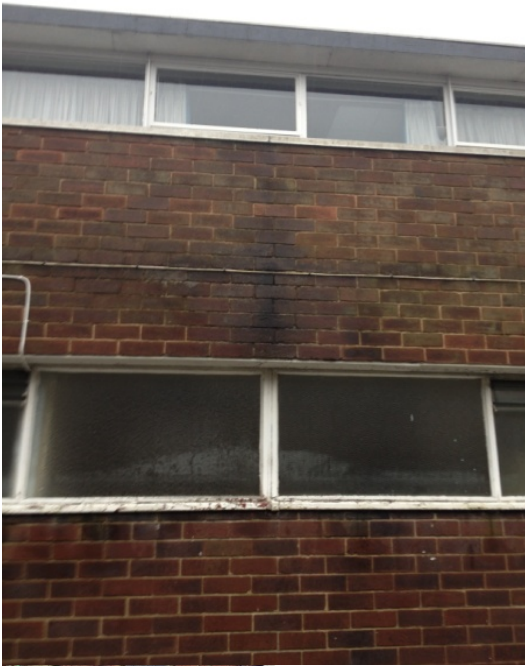
Leakage through brickwork due to ponding on roof area 3.

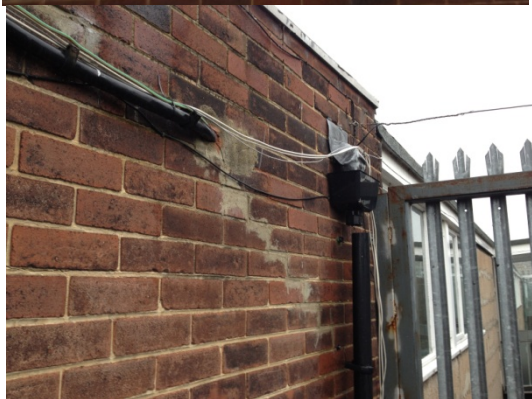
There are a number of instances of patch repairs, plastering and painting over internal cracks which do indicate movement over the period, with anecdotal evidence that this is an on-going issue. The extent of cracking currently evident in the retained areas does not suggest significant structural works at this time, however a monitoring regime is recommended and remedial measures may become necessary if movement is shown to be on-going.

Cracking to NW end of roof 2, no elevation reference showing potential evidence of continuing movement.

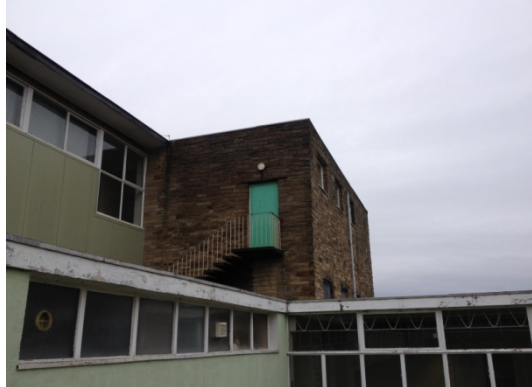
Elevation E10A, repairs recommended repairs not carried out. Loose stonework to corner needing repair.

Repairs are required to damaged masonry to elevation E10A to prevent risk of masonry falling and damaging the building further.

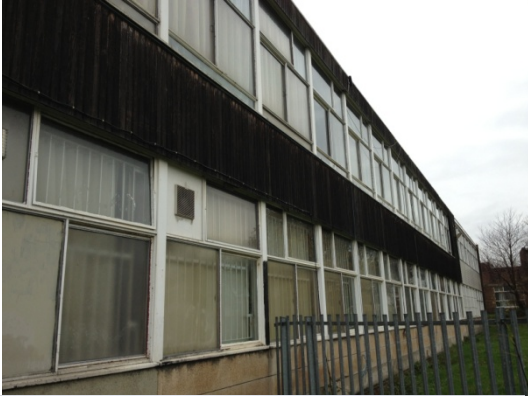
Elevation showing general degradation typical of the perimeter.

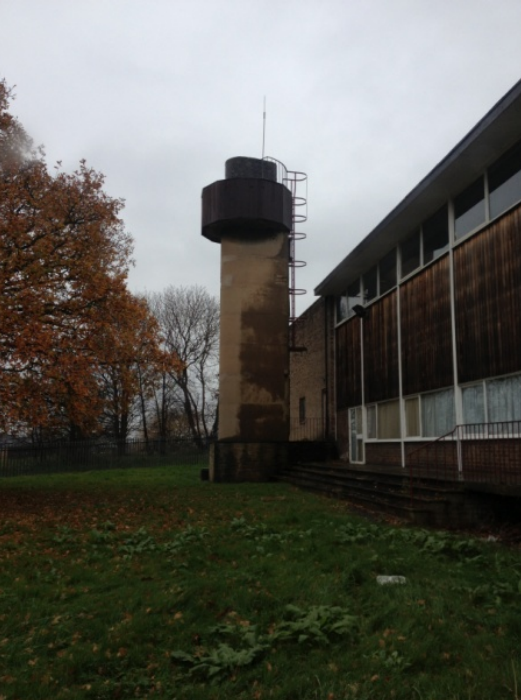
Spalling and degradation to water tower, section loss and exposed rebar. Elevation E6.

Spalling and degradation is evident to the water tower, these should be further investigated and concrete repairs undertaken to prevent further degradation.

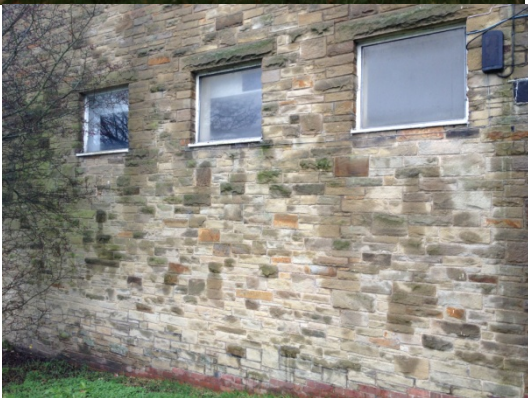
Cracking to Ashlar wall. Potentially settlement.

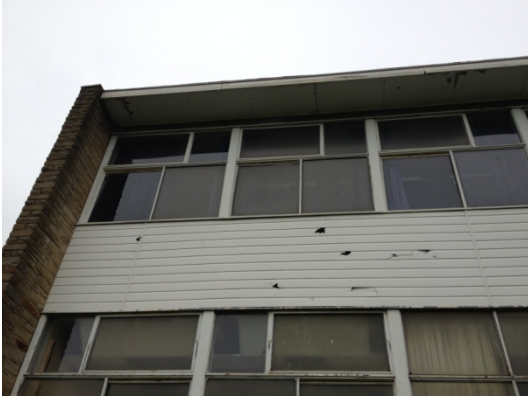
Deterioration and damage to cladding and soffits elevation E24.

Repairs should be made to areas of external cladding and soffits that present a risk of coming loose and falling from the building as a minimum.
