Leeds City Council

**West Park Community Centre**

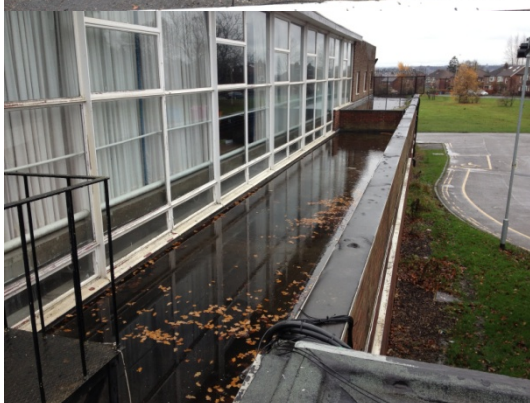
**Significant ponding to flat roof area 3.**

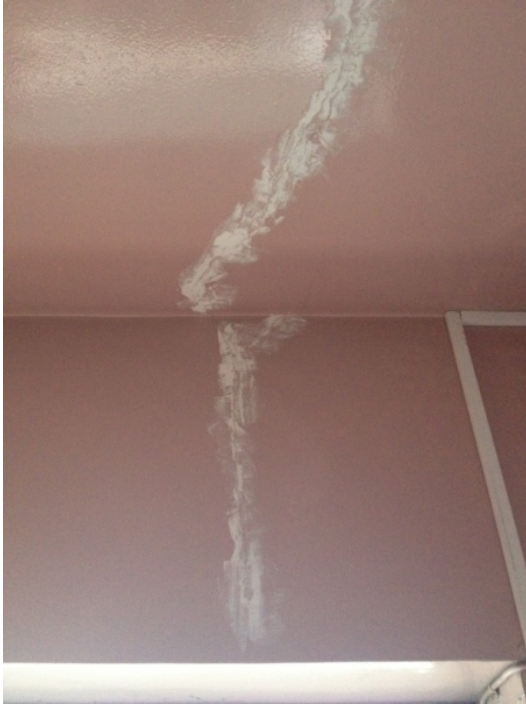
**Office areas G224-232. Example of cracking to soffit with evidence of potential continuing movement.**

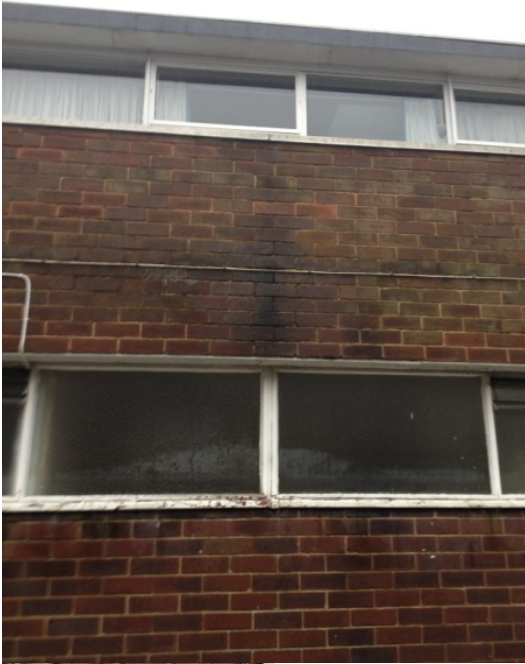
**Leakage through brickwork due to ponding on roof area 3.**

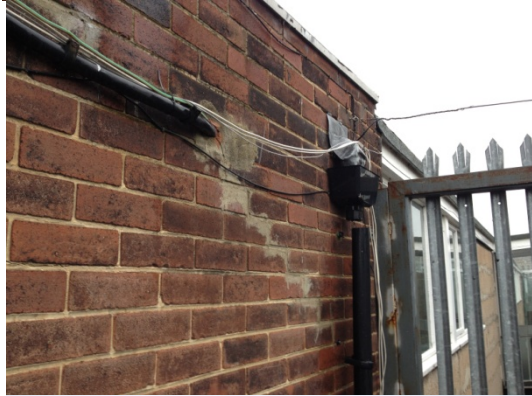
**Cracking to NW end of roof 2, no elevation reference showing potential evidence of continuing movement.**

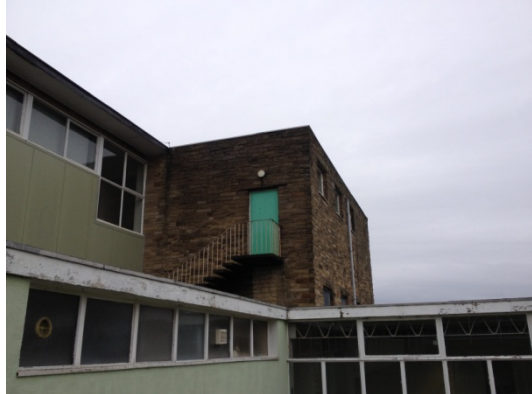
**Elevation E10A, repairs recommended repairs not carried out. Loose stonework to corner needing repair.**

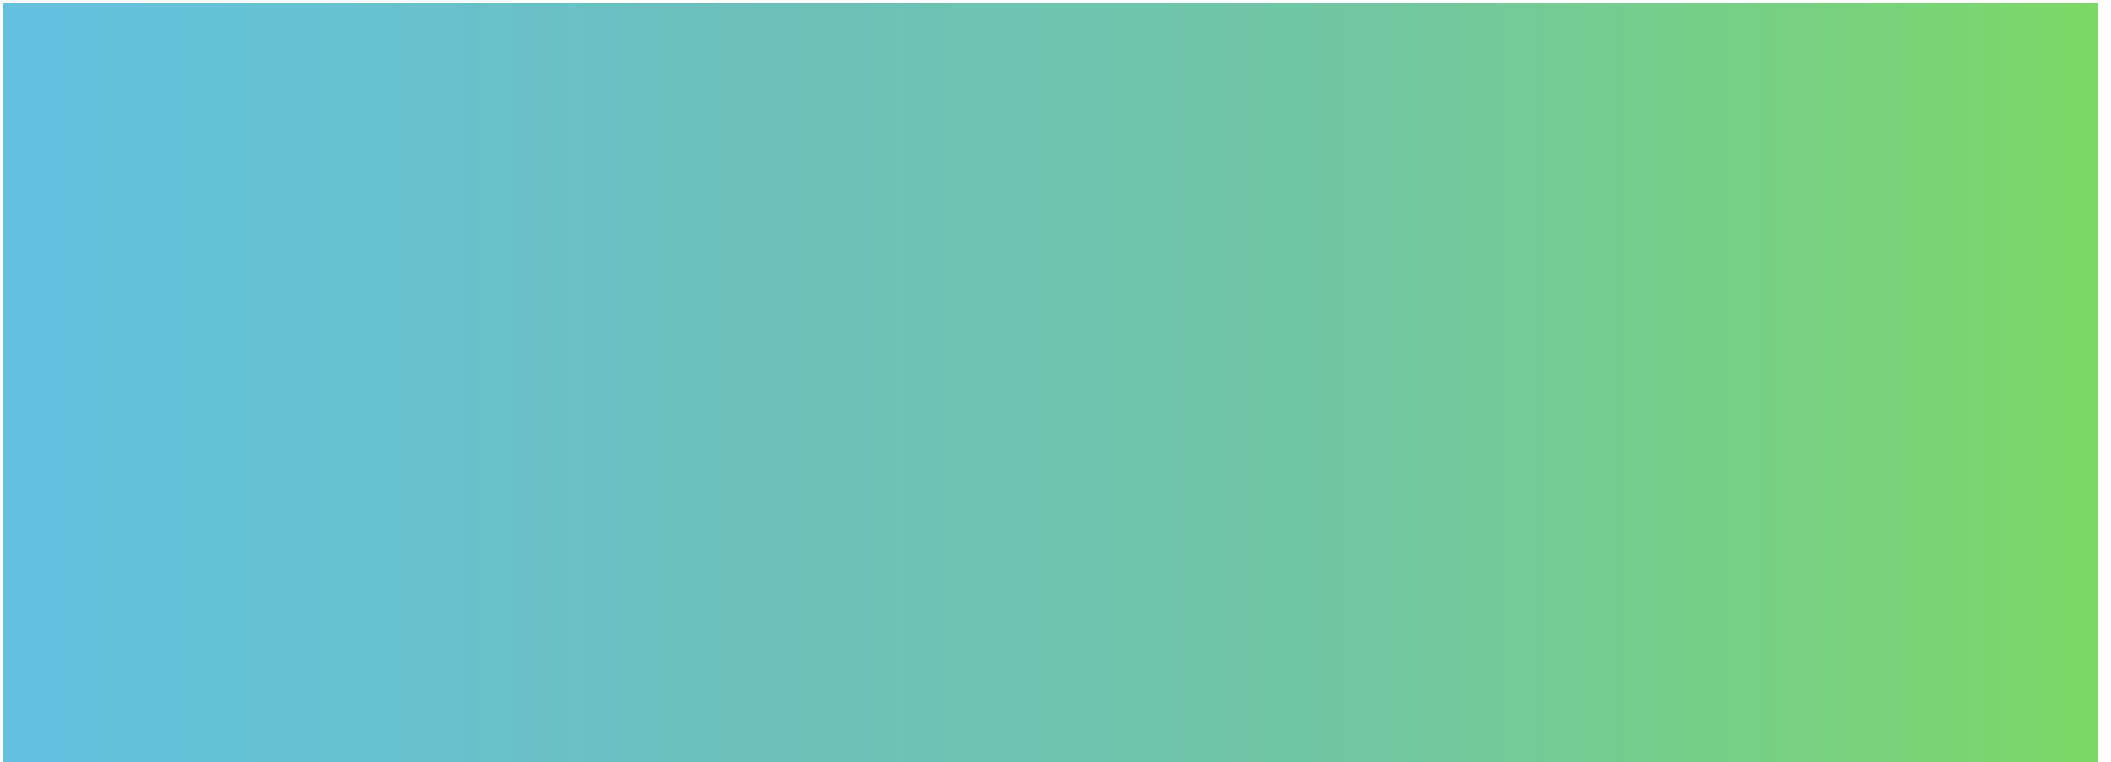
# West Park Community Centre, Leeds Budget Estimate Nr 4 - Option 1A
