ARBORICULTURAL SURVEY BS 5837:2012 Trees in relation to design, demolition and construction - Recommendations

Prepared by Parks and Countryside – Forestry Section

Report No: A660 Headingley

Date: 28th November 2022

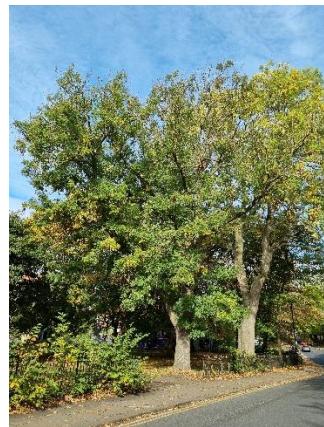
T72/T73

73	<i>Fraxinus excelsior (common ash)</i>	18	95	7	7	7	6	M	Poor	poor	Ash dieback present tree in declining condition	Remove tree and stump grind	1140	20+	C

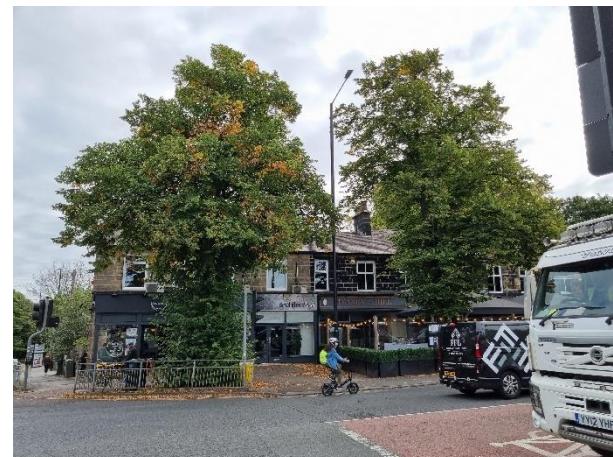
T1 and T2

(m)								
T1	<i>Tilia spp. (lime)</i>	9	50	5	5	SM	Good	Bifurcated stem at 2m, potentially an old pollard, dense epicormic growth	Good leaf size colour and vigour	Remove epicormic growth	600	40+	B
	(OS Bowery café)			5	5								
T2	<i>Tilia spp. (lime)</i>	12	54	5	5	SM	Good	Cavity at base of tree on south side, further investigation ideally required. Minor cracking of resin bonding surface due to root expansion	Good – under private management and part of dining forecast	Remove epicormic growth	648	40+	B
	(OS Heaney and Mill)			5	5								
T4	<i>Alnus cordata (Italian alder)</i>	6	25	3	3	Y	Good	Typical for age, species and highway location	Tip reduce branches to give visibility to highways sign	Christmas lights present in tree, ideally need adjusting to prevent bark damage	300	40+	B

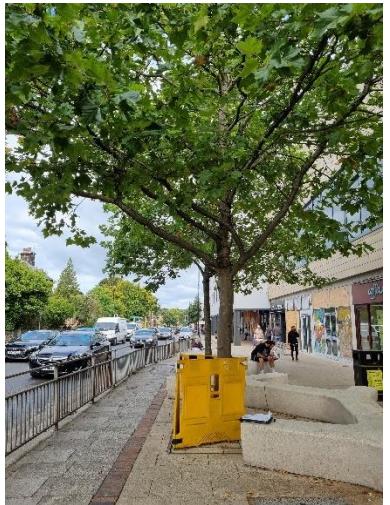
OS Greggs/TRAD collective														
T9	<i>Platanus x hispanica</i> (London plane) OS Costa coffee	7.5	25	5	3	3	3	Y	Good	Good	Good	Christmas lights present in tree, ideally need adjusting to prevent bark damage. Minor pavement lifting.	300		B

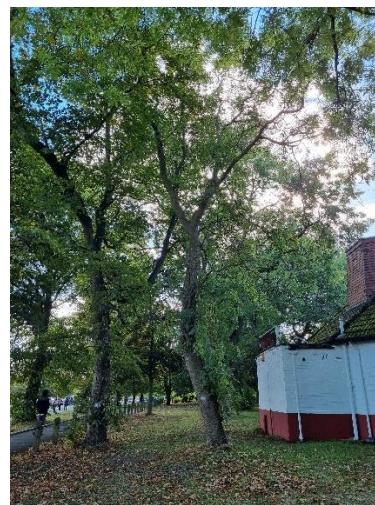
Woodhouse Moor Ash (off site)

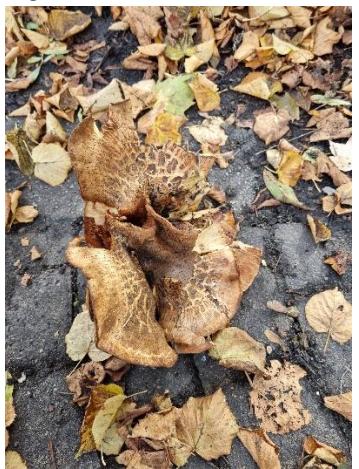
T69 fungus
