Report of the Director of City Development

Scrutiny Board (City Development)

Subject: SAVINS MILL GYRATORY, SAFETY SCHEME

Accident Study

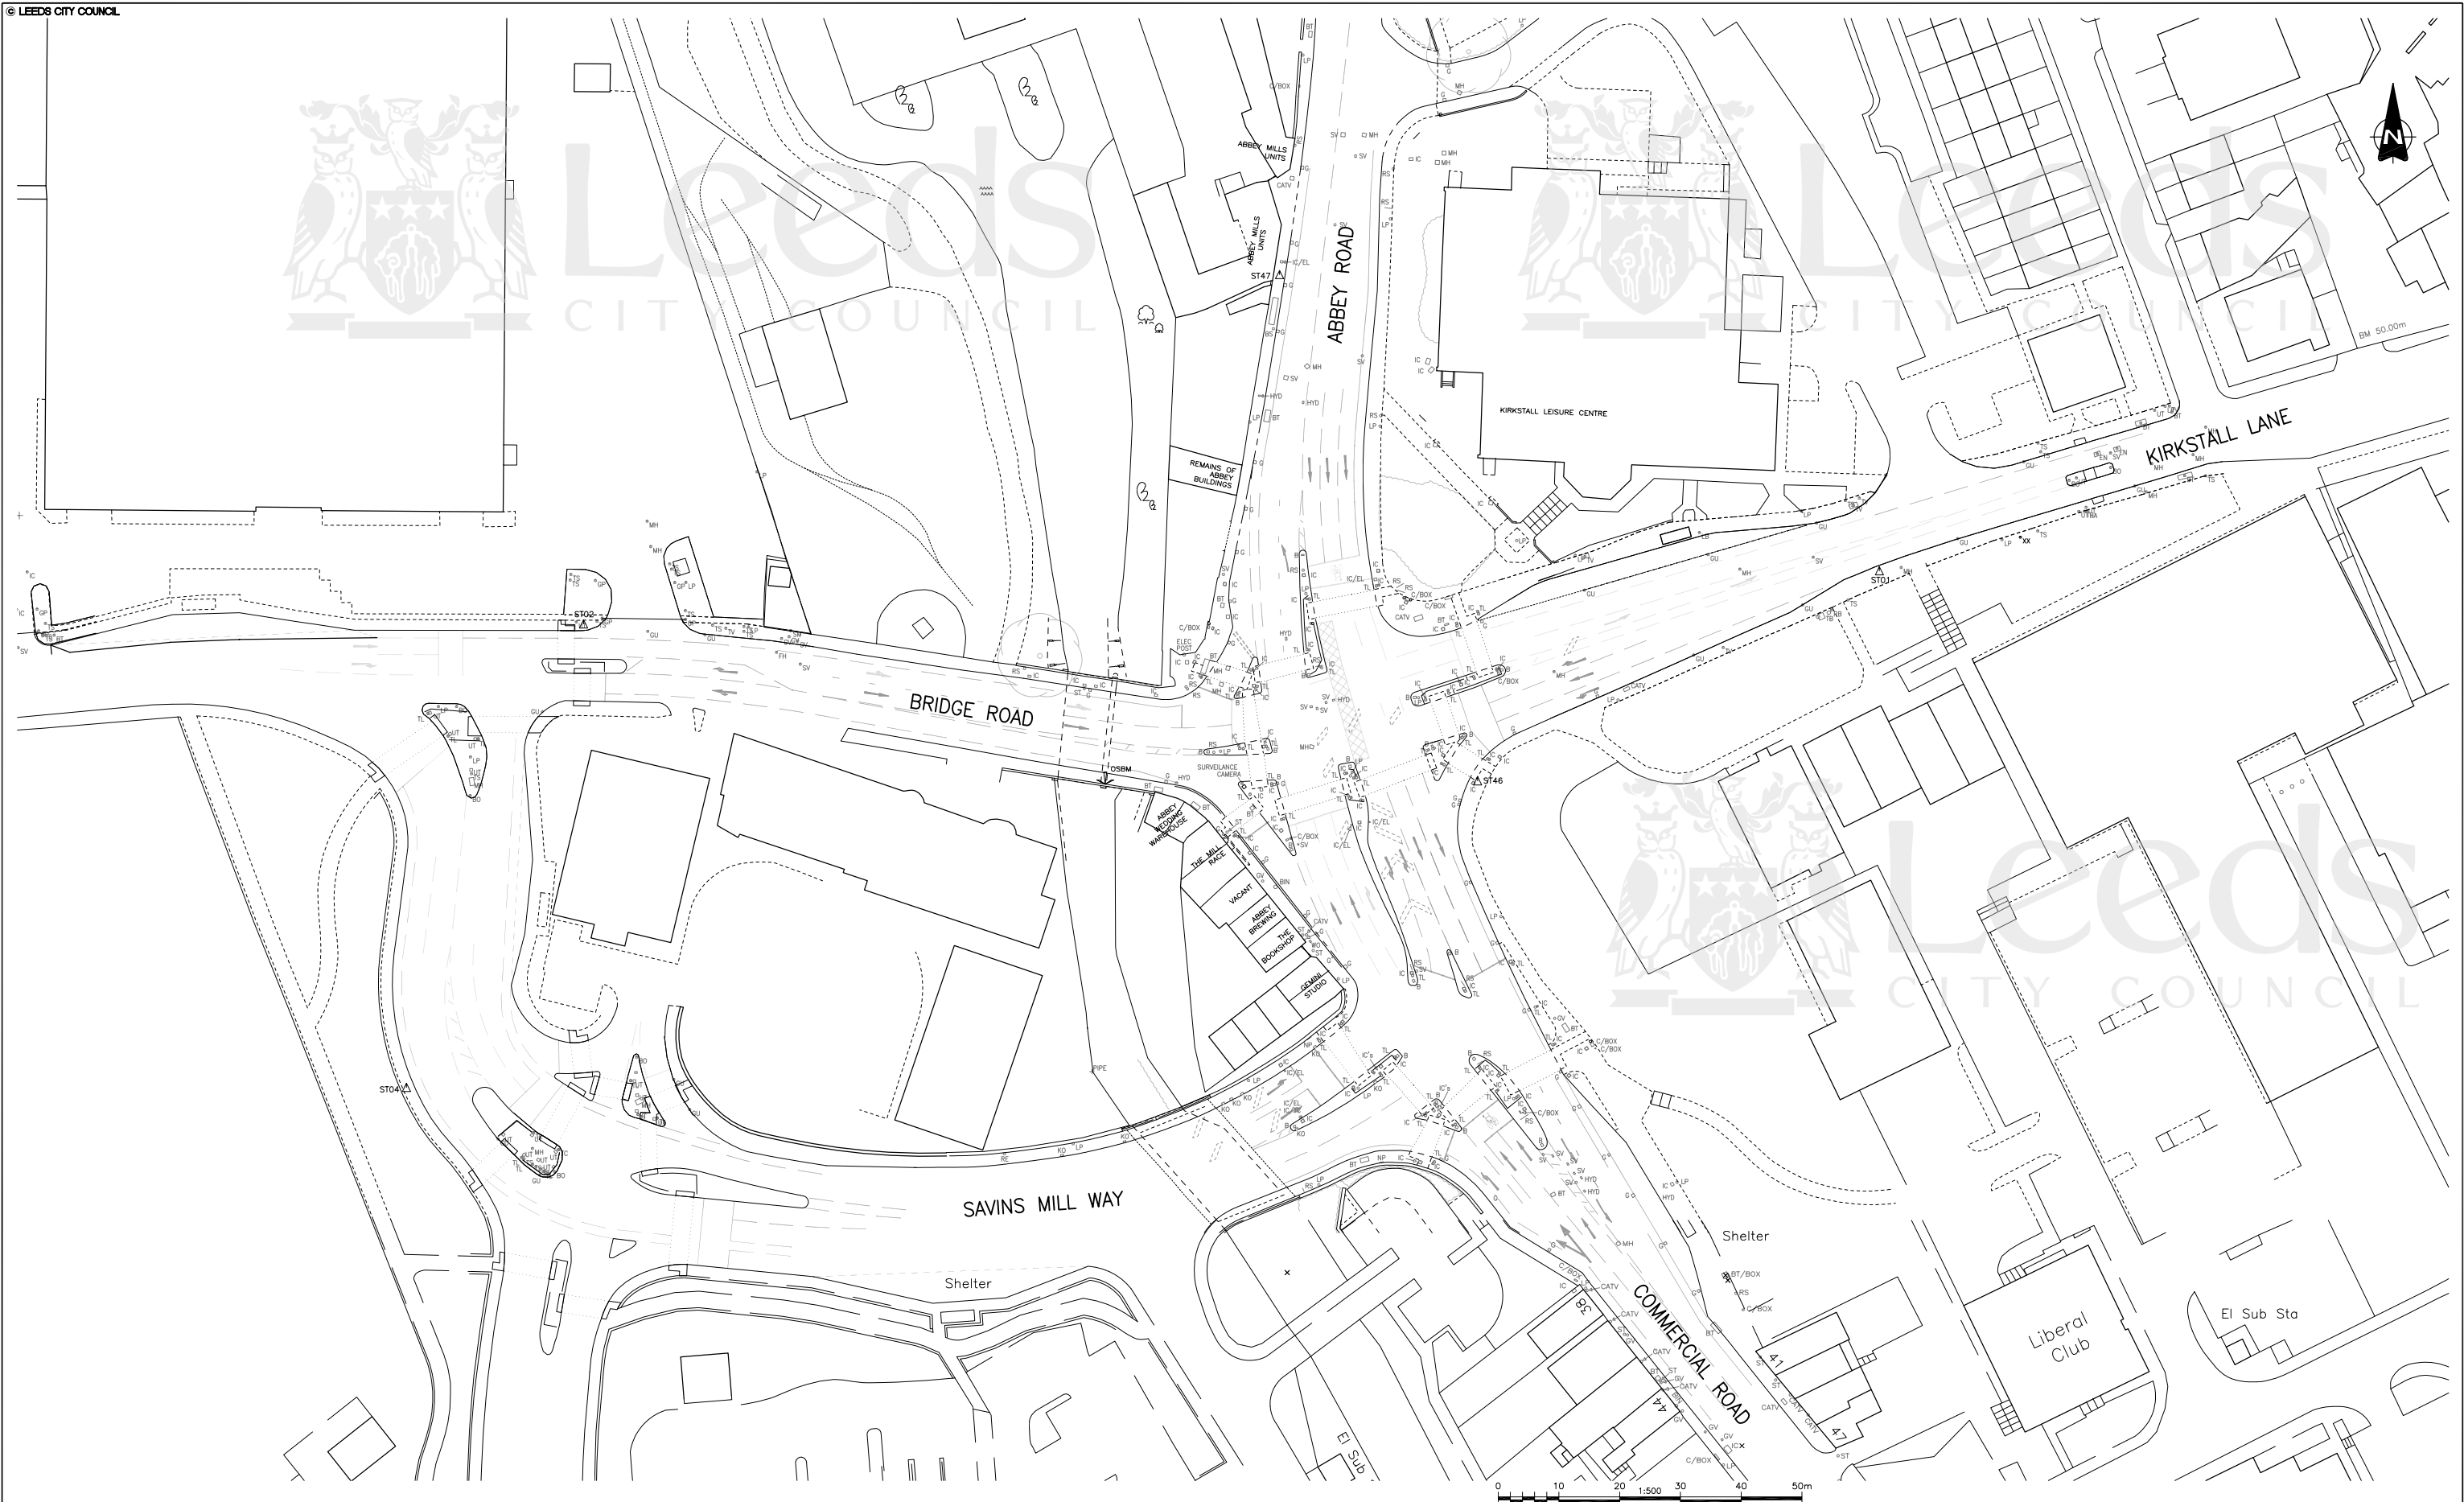
DRAWING NUMBER:
HDC/298732/MIS/01
 DATE: **June 2008**

Right turn conflicts – According to the computer-held data, four of these involved the prohibited turn from Abbey Road into Bridge Road and a further 3 involved the similarly prohibited turn from Bridge Road into Commercial Road. Four involved the right turn from Commercial Road into Kirkstall Lane, with the final two being the Kirkstall Lane into Abbey Road manoeuvre.

Red light violations – Two of the red light violations were “west/east versus south/north” manoeuvres and the third involved an “east/west versus south/north” manoeuvre. In none of these cases was the offending vehicle positively recorded.

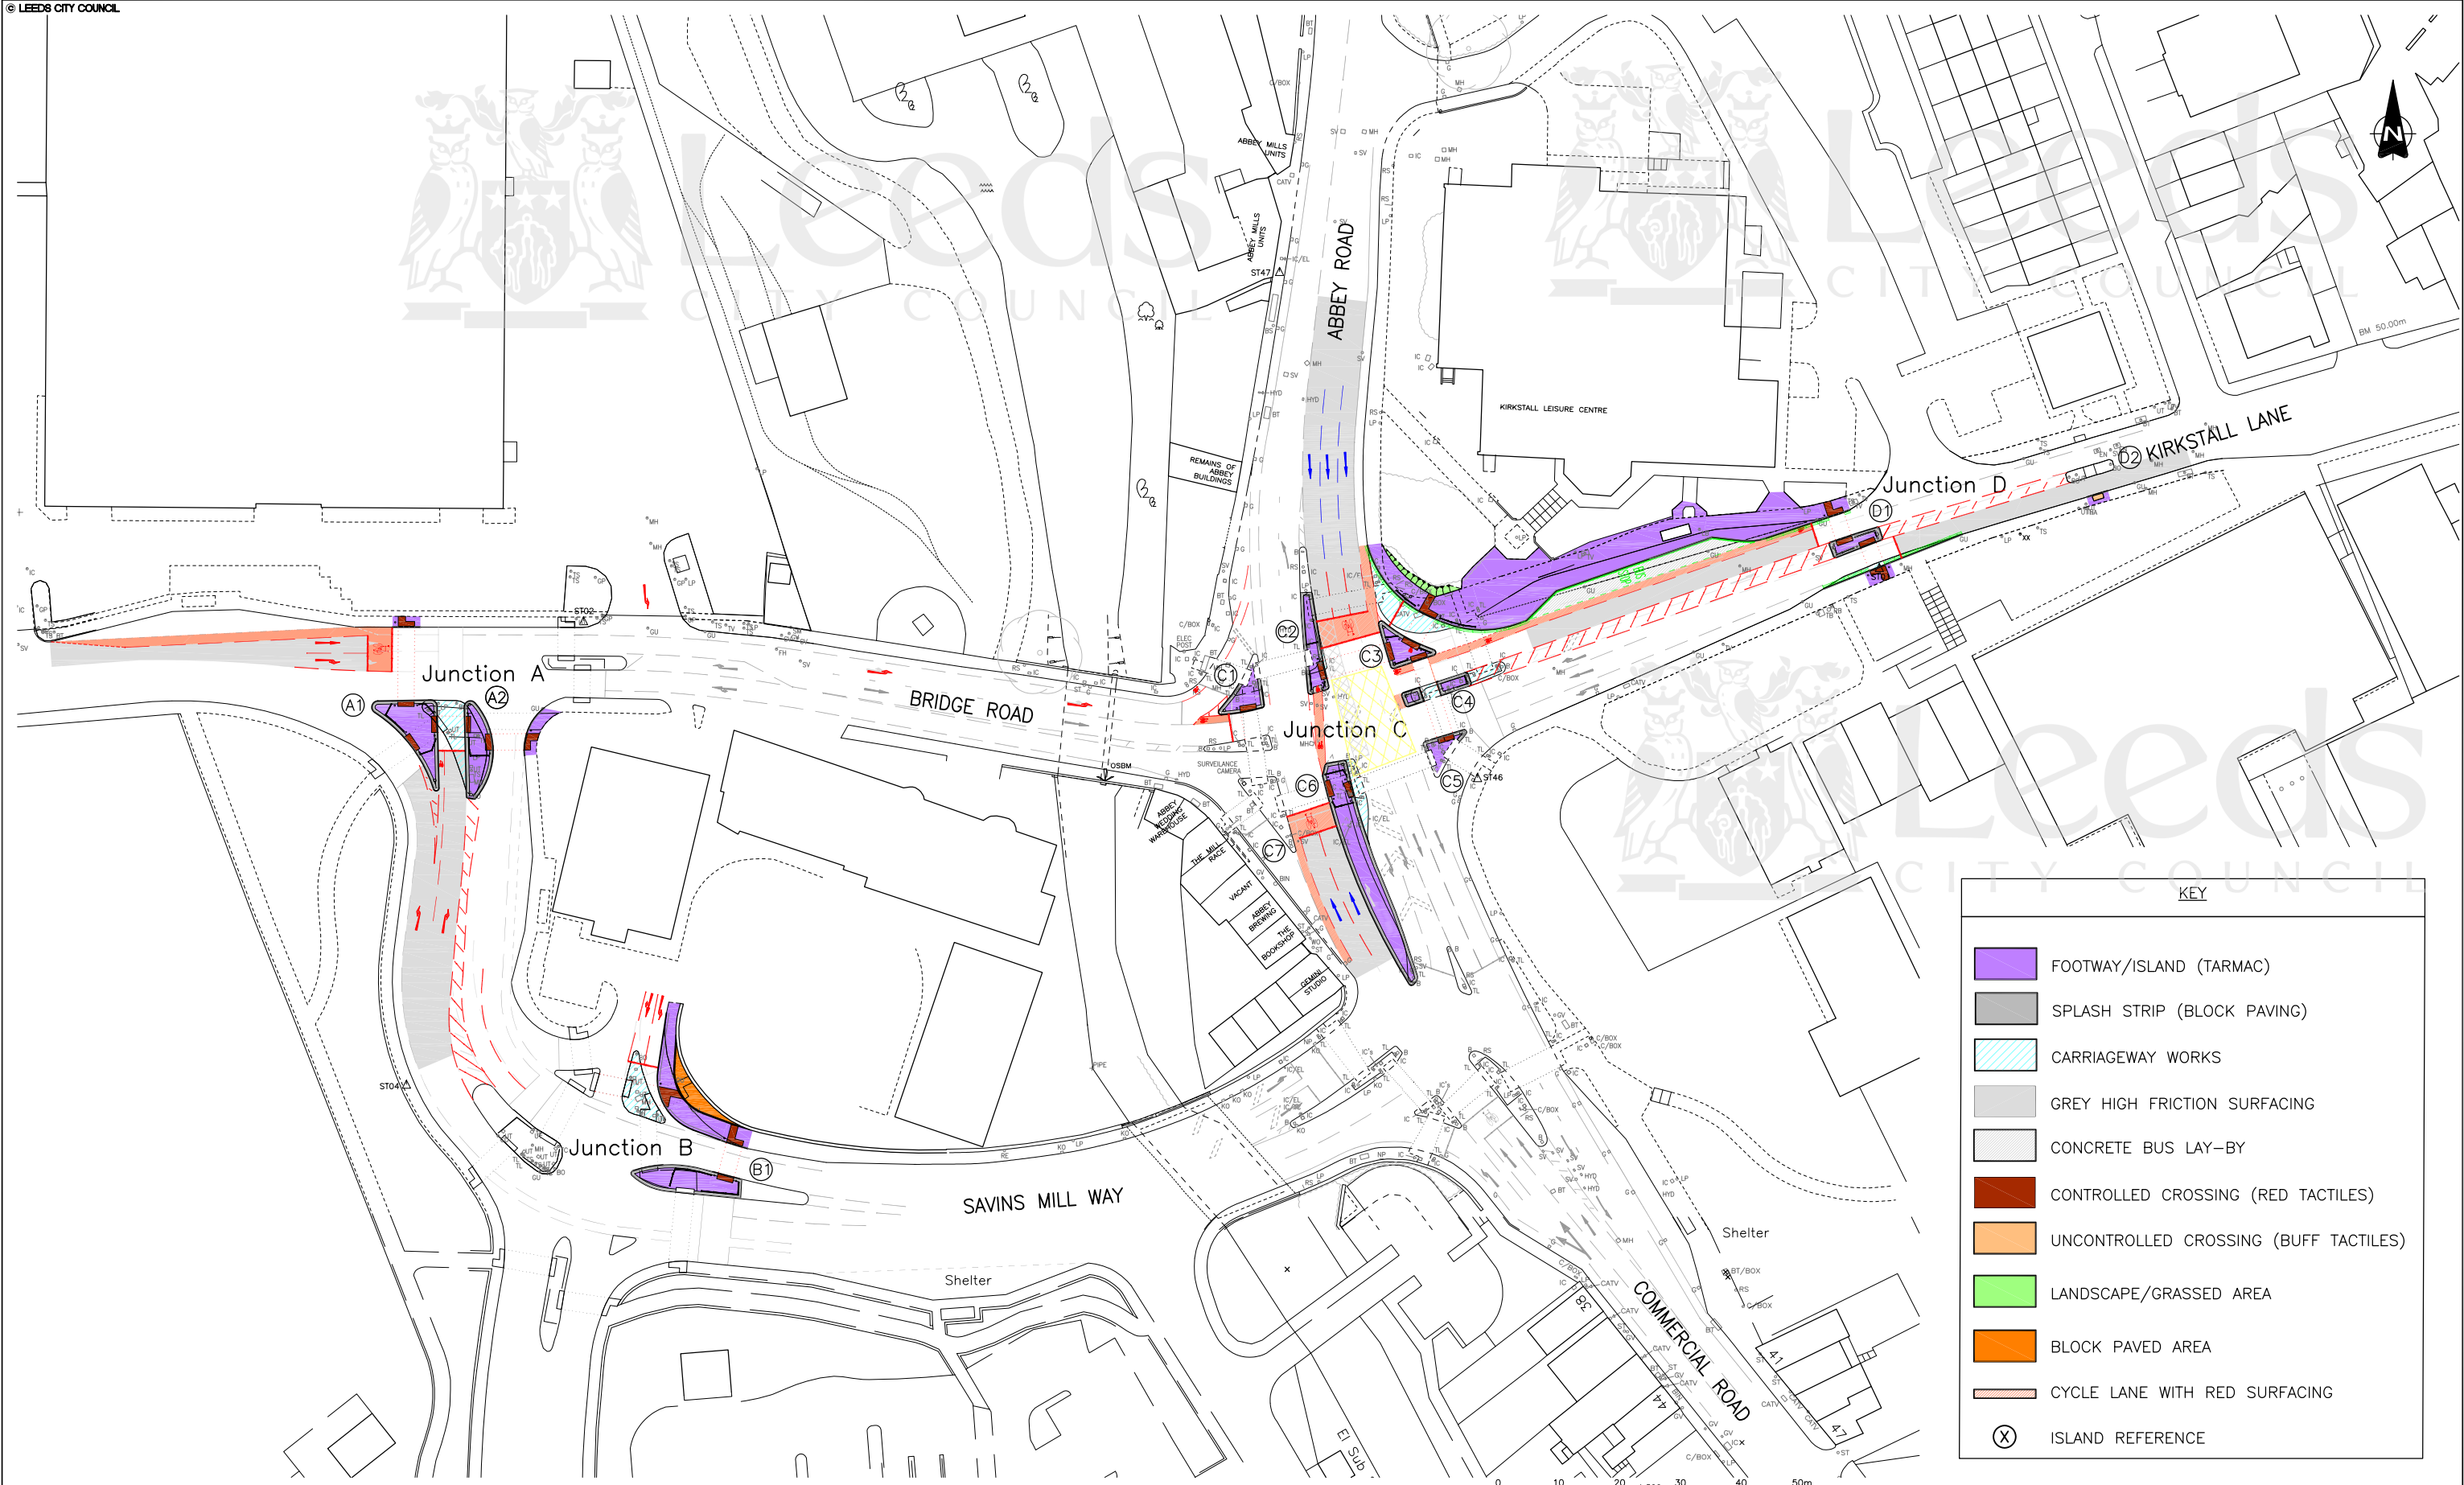
DRAWING NUMBER:	HDC/298732/01/01
DATE:	April 2008

- 3.2 The scheme proposals seek to address issues identified in the 2003 Accident Study by implementing the recommendations it makes. The main issues are,

- i) Right Turn Conflicts;
 - ii) Nose-to-tail Collisions; and,
 - iii) Red Light Violations
- 3.3 The scheme proposals can be seen on Drawing Number HDC/298732/01/01. This scheme looks to address the issues above in line with the 2003 Accident Study.

- 7.1 Right turn conflicts at Kirkstall Lane / Abbey Road. It is recommended that capacity be identified within the current set up to provide adequately for the separate signalling of the right turn manoeuvre from Kirkstall Lane into Abbey Road.

- 7.2 Right turn conflicts at Commercial Road / Kirkstall Lane. It is recommended that this turn be prohibited and that drivers wishing to access Kirkstall Lane be directed there via Savins Mill Way, turning right onto Bridge Road where the signals are to be amended to accommodate this move.

- 7.3 Red light violations. The problems associated with the “read through” red light violations can best be addressed by the complete removal of the signal heads pertaining to oncoming vehicles and the removal of the corresponding Stop line. These signals provide a suitable red/green man facility for pedestrians, but are never used to control traffic movement and their removal will prevent drivers from becoming confused.
