Appendix C – Photographs and Figures

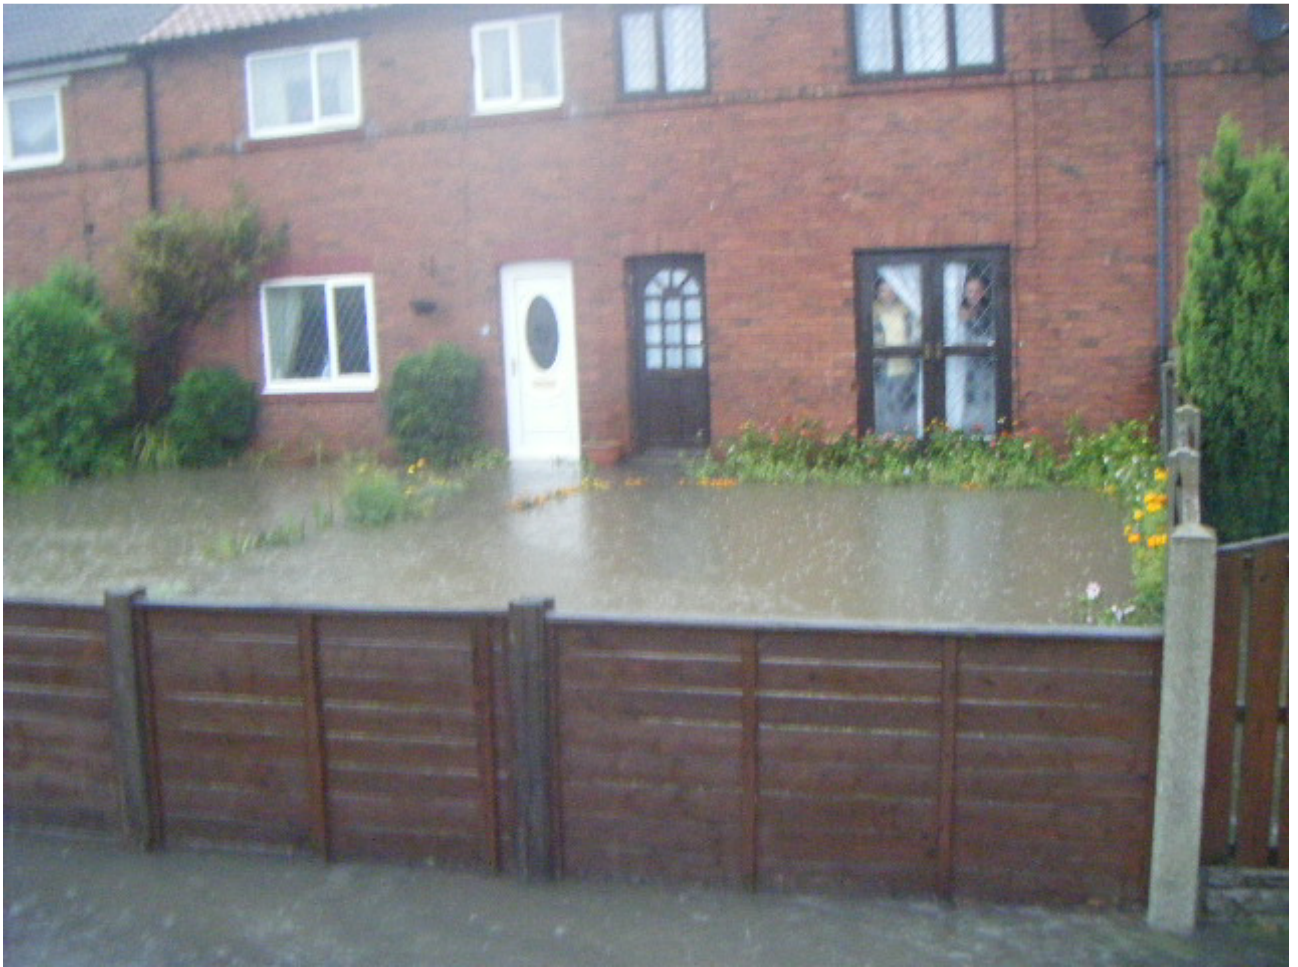
Figure 1 – Flooding in Leeds Road – Allerton Bywater August 2014

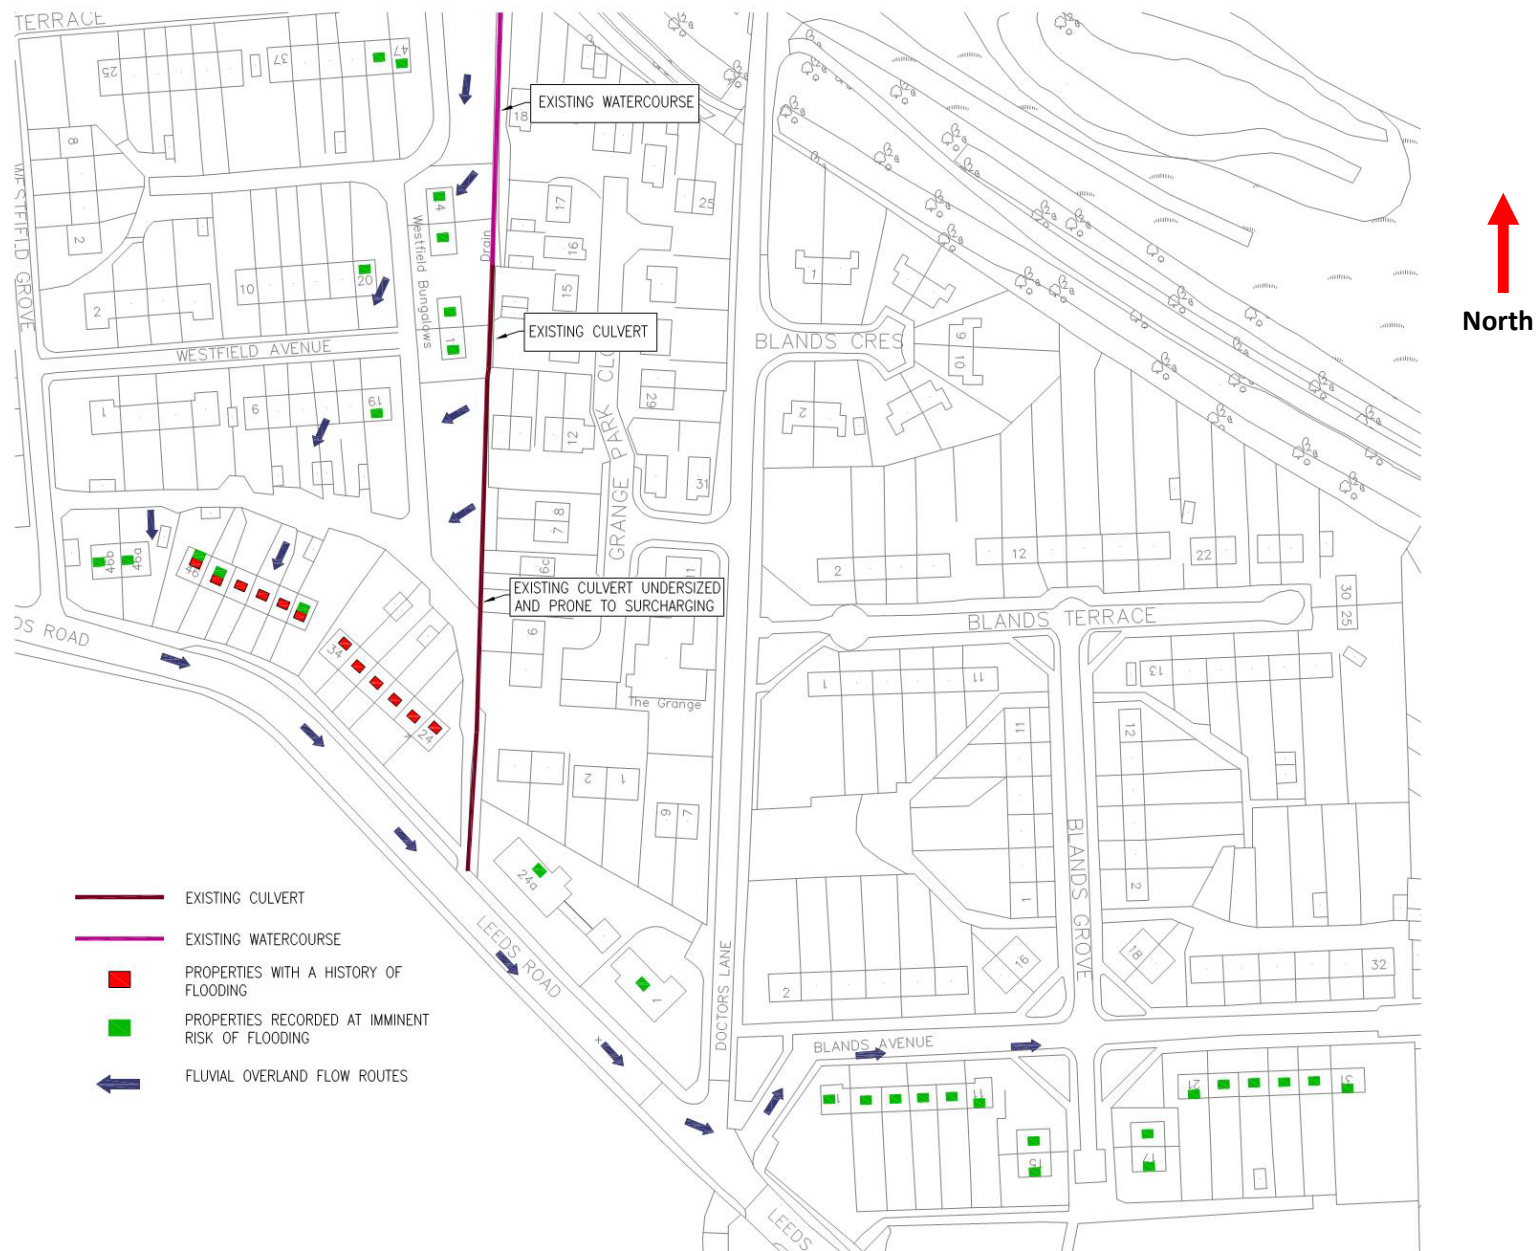
Figure 2 – Existing properties at risk and key site features – Westfields

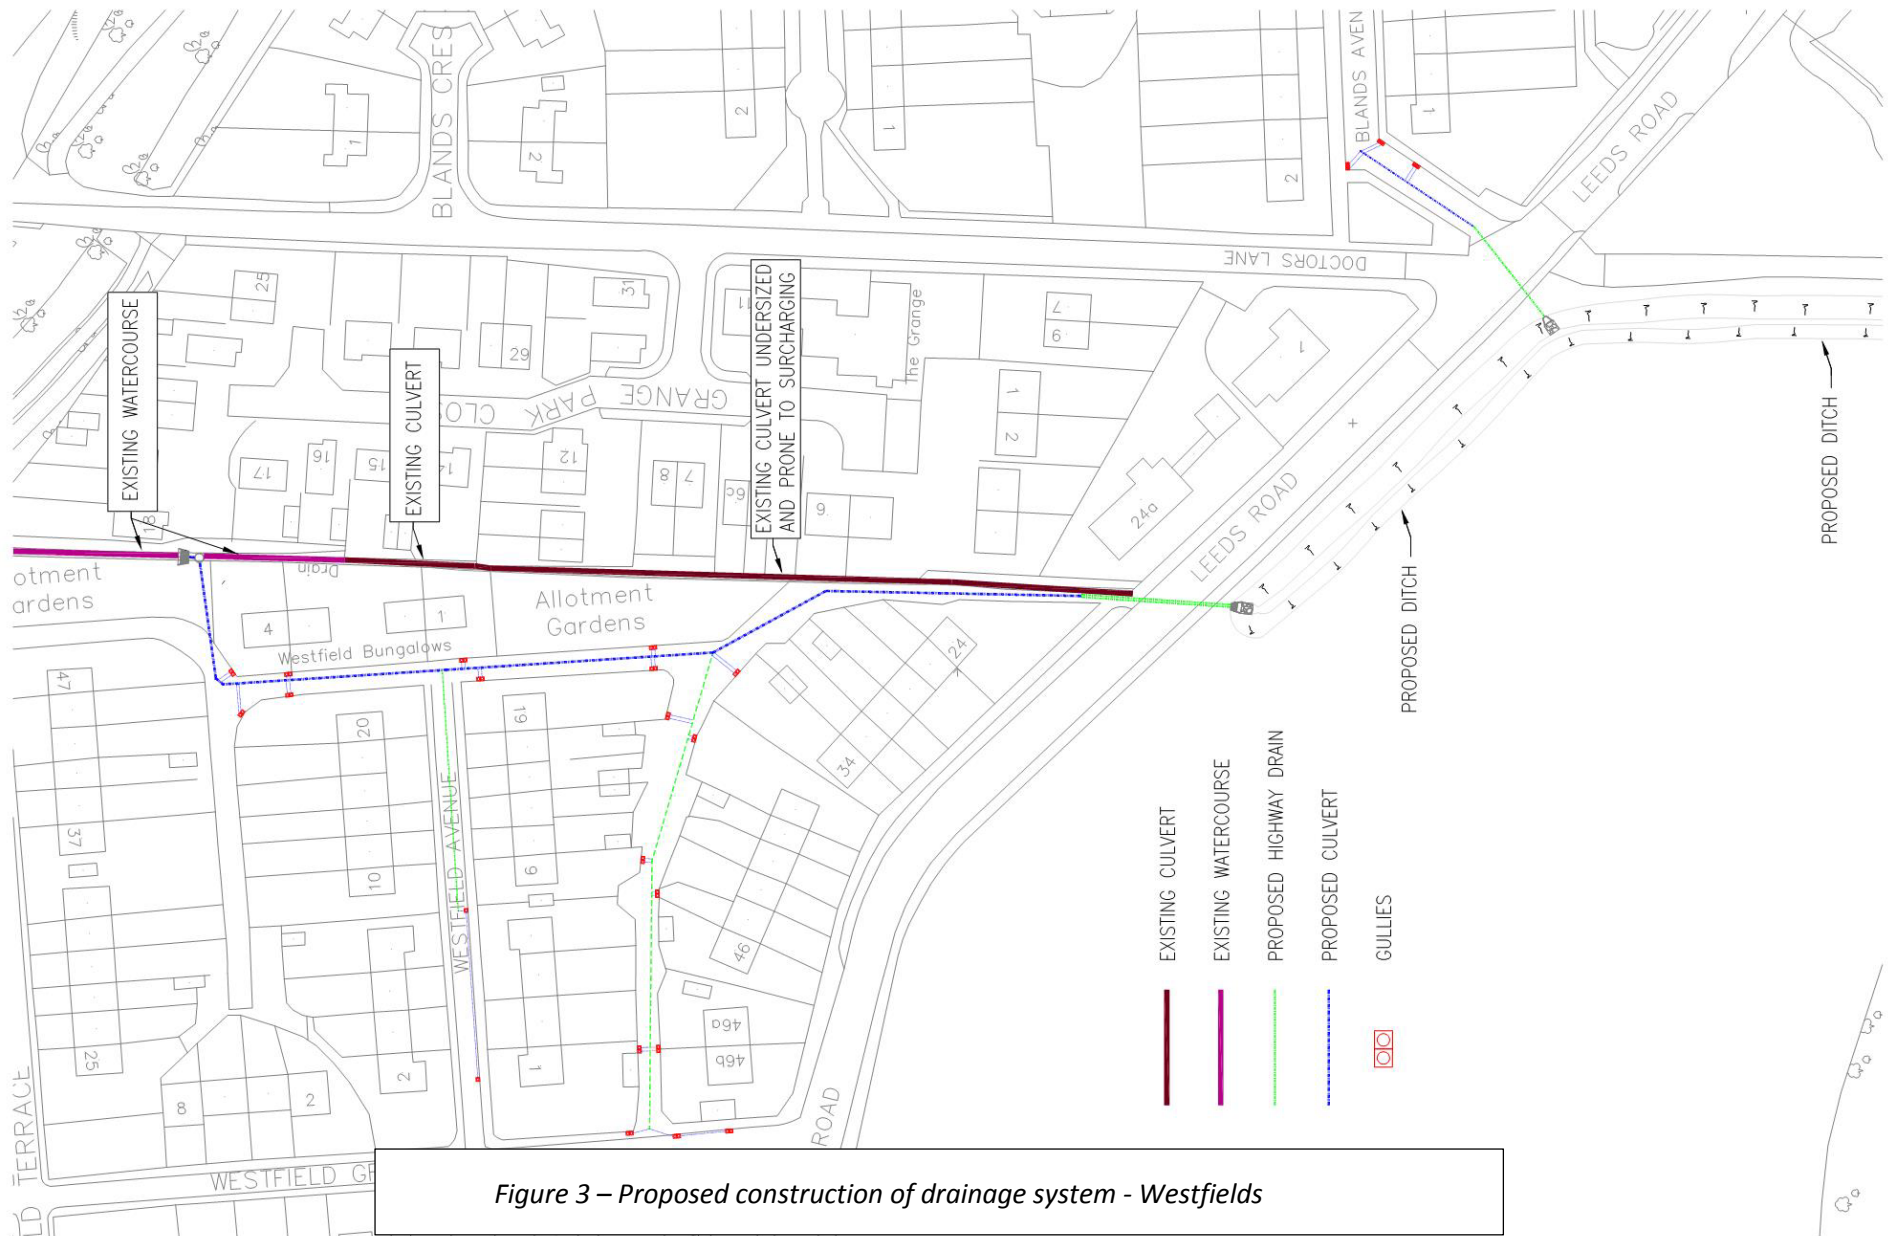
Figure 3 – Proposed construction of drainage system - Westfields
