Leeds City Council **West Park Community Centre** Condition Survey Review Desk Study and Visual Survey

Issue 2 | 26 November 2012

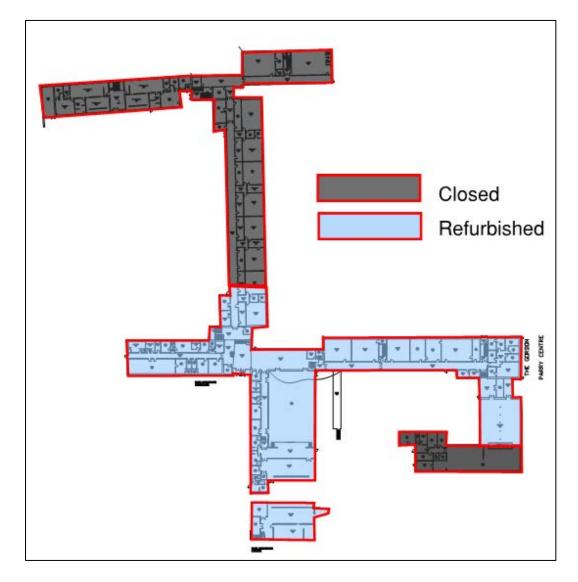
It is considered feasible to partially close the building and re-open a portion. The diagram below shows one suggestion of the most feasible position to make this delineation.

Given the need for significant mechanical and electrical works, it is logical that that the retained portions of the building are the section adjacent to the central plant spaces. These spaces, effectively the south west wing, also potentially offer the greatest flexibility in use. The North East wing and central linking corridor could feasibly be separated from the retained building and decommissioned and made safe.

As part of this works the service trench, the source of the water ingress to the plant areas, should be cut off and fully blocked up.
