West Park Community Centre

Full/Partial Demolition of West Park
Community Centre – Feasibility
Study

ISSUE | 9 April 2013

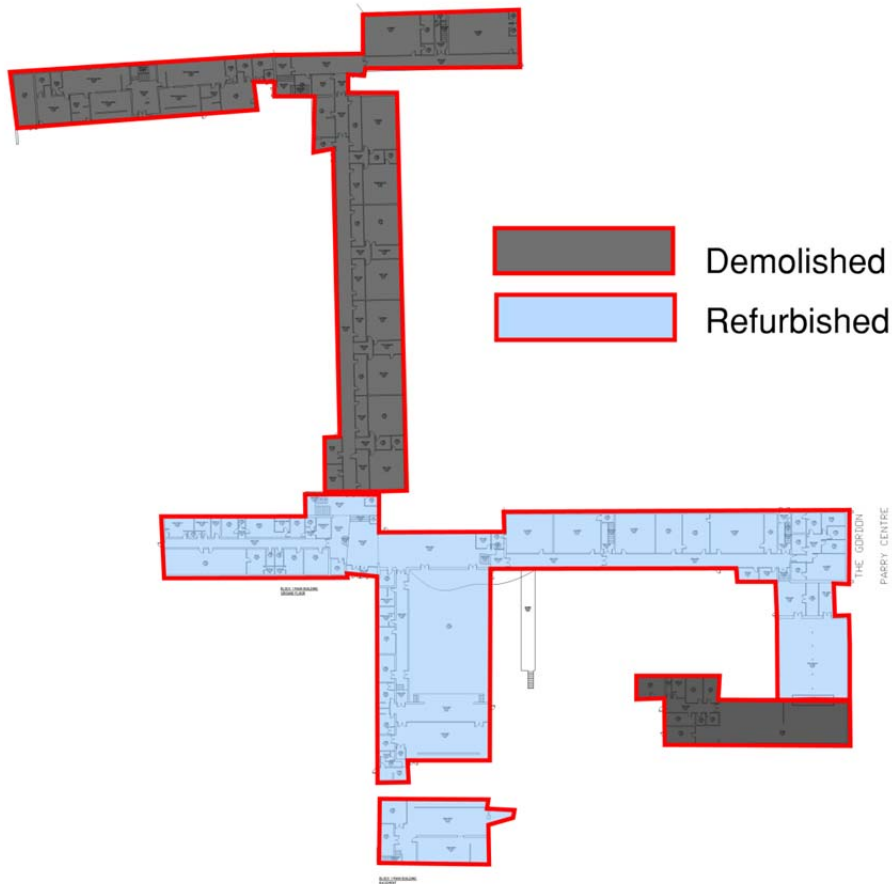
It is proposed to partially demolish the buildings at West Park and retain a portion of the facilities. The proposed line of demolition is indicated below.

Consideration has been given to retaining the toilet facilities to the north of the proposed demolition line, however the natural break line is as indicated, retaining the toilets would require additional temporary works to stabilise and weather proof the remaining portion.
