Baffle Structure - Outline Maintenance Requirements

Project Bridgewater Place
Subject Baffle Structures Outline Maintenance Requirements
Project no 032543
Date 20 February 2015

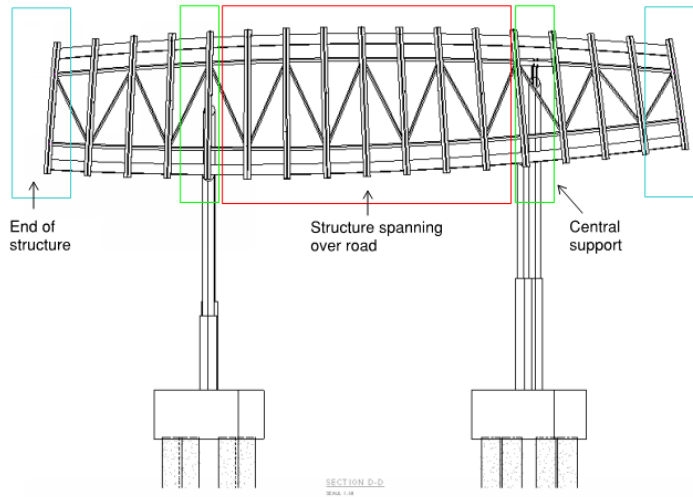
Proposed Access Routes to Baffles Site:

<i>Location</i>	<i>Proposed Access Route</i>
Ends of Structure	On foot via footways
Central Support	On foot in conjunction with partial lane closure of road, if required
Structure spanning over road	Mobile elevated work platform located in Water Lane in conjunction with partial lane closure of road
