Part (2) A – Wharfe Meadows, Titty Bottle and Manor Parks

1. Site Specific Recommendations

1.1 Summary of Rationale for Recommendations

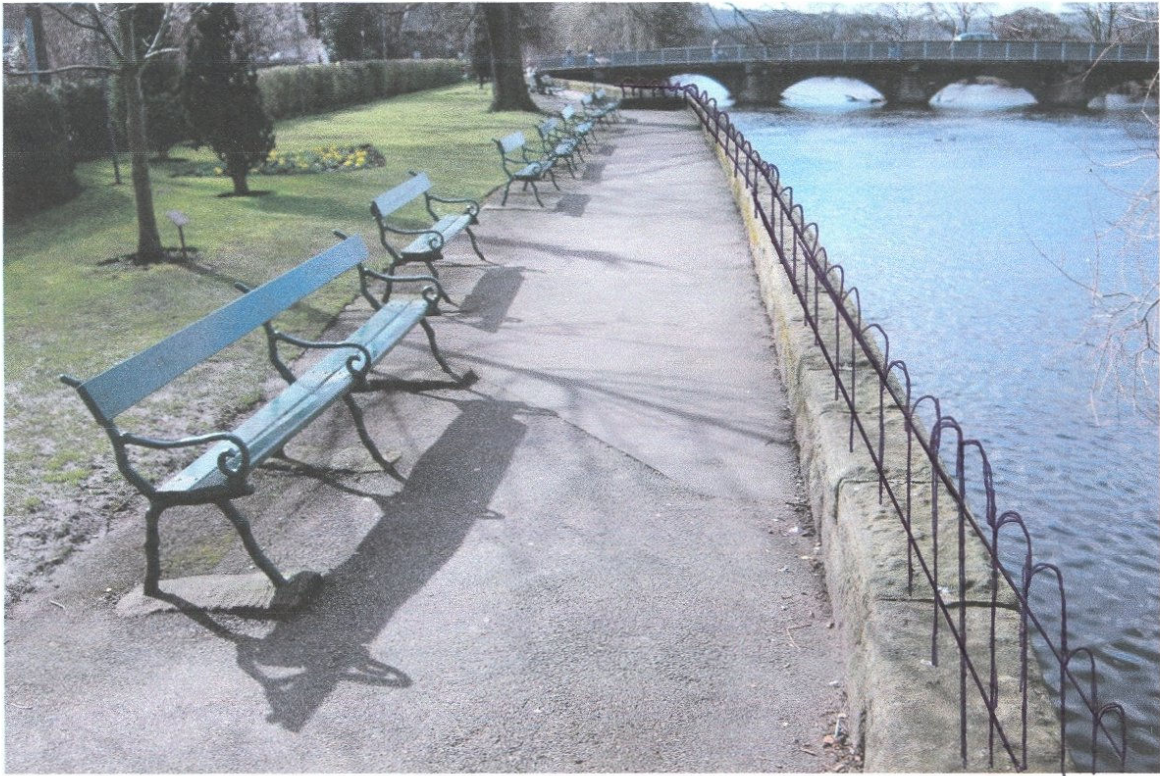
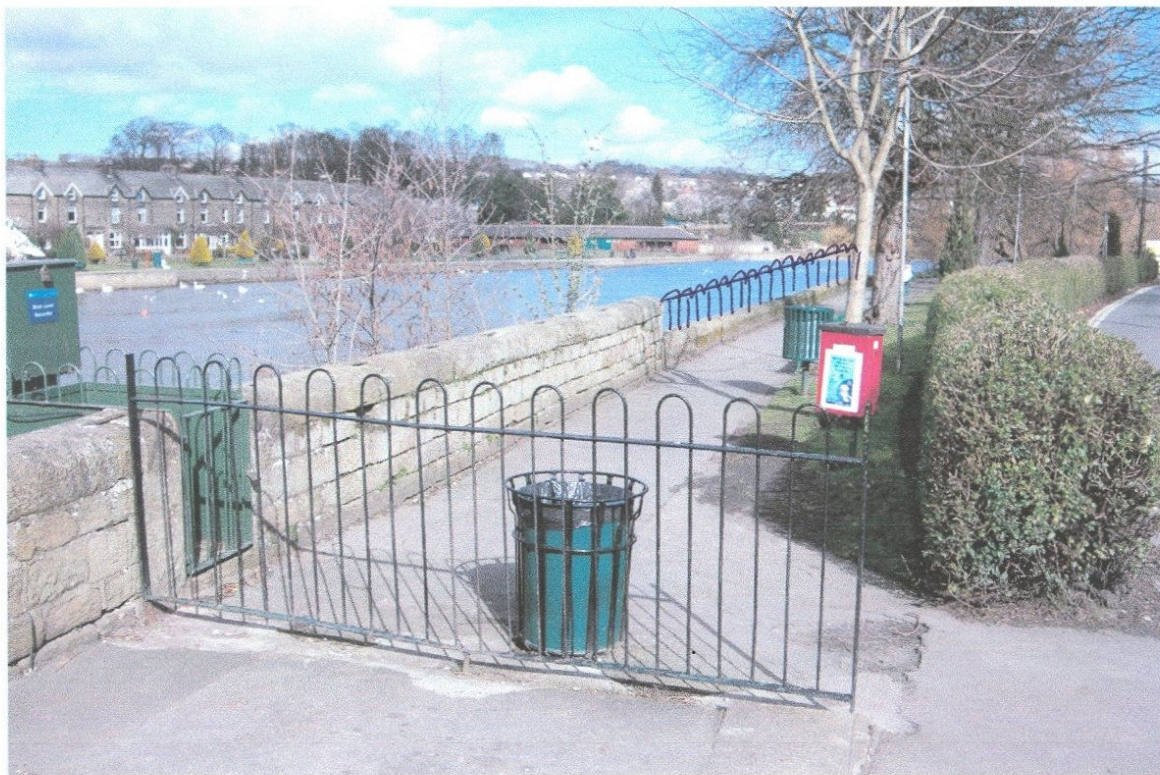
Titty Bottle Park Fencing

- *It is recommended that you take action to cut the trees over hanging the river, which act as a magnet to children to climb over the water.*

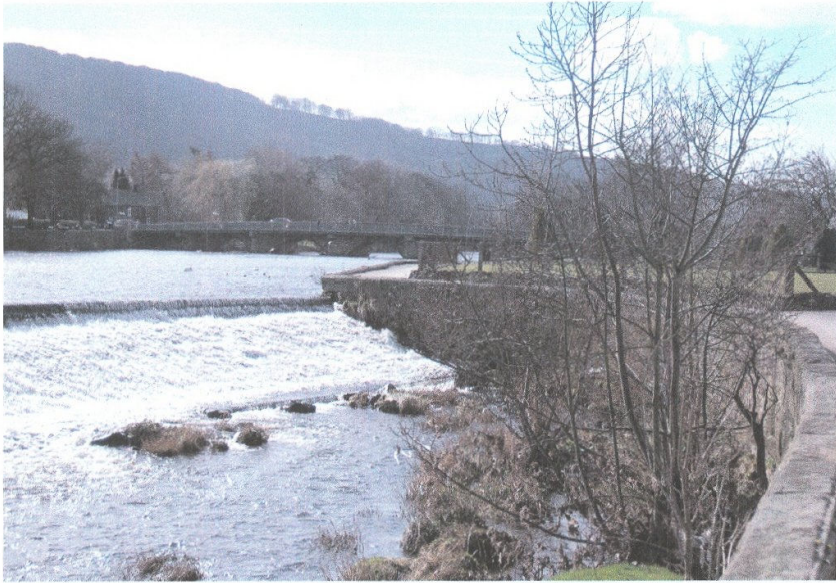
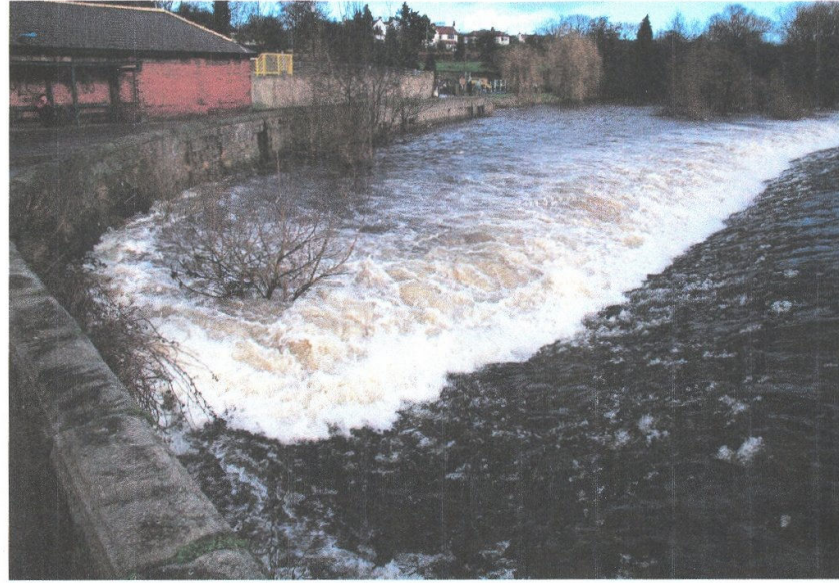
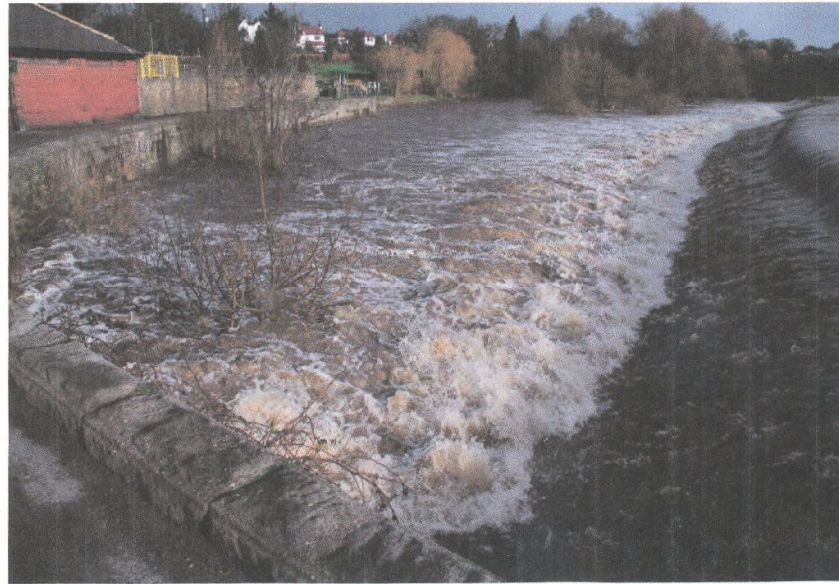
Wharfe Meadows Park Weir in Low and High Water Levels

RoSPA visited the site in the autumn and subsequently came up with a clear solution to the considerable water safety hazard viewed on site, that primarily being the presence of large steep weir that is found within the site, this weir which is 75m long and has a fall of 5-6m on the downstream side is little more than 20m downstream from the wildfowl feeding area that is popular within the park. In any raised water levels this weir would be very dangerous, which lead the consultant to suggest linking up the existing fencing that was onsite. RoSPA would never usually recommend the fencing off of waterways, but due to the presence of such a large and potentially dangerous weir we felt that this time some edge protection was required to stop deliberate access to the weir and protect those that accidentally fall in from being swept over the weir.

The difficulty in assessing this site is that the River Wharf, a typical Yorkshire river draining the limestone and in places grit stone Pennines and dales, is subject to substantial variances in flow and height. During the summer in periods of dry settled weather, the flow will be such that relatively only a trickle will be going over the weir and the historical hiring of rowing boats shows that the weir creates almost a pool upstream, which

apart from the depth would be relatively benign. A completely different scenario can be found during the winter when the whole of the lawned area adjacent to the steps can be flooded when the river is running 2m or 3m higher and flowing at up to 10mph or more.

Edge protection is required and signage can be used to support water safety. This is an urban site and those that access the site from the playground and downstream expect the path to be a significant distance away from the water and where it is adjacent to the water it is currently fenced, we always strive to be consistent in our approach either there is open access or not, compromises and a mixed approach send out mixed safety messages. Tourists and those not familiar with the site would not be aware that when turning around the bend they would currently be met with an absence of fencing up to and beyond the weir.

A option version for an aesthetically more acceptable design to edge protection, would involve the positioning of fence lines along the existing low wall/coping stone top and encouraging the main pedestrian flow through the park where possible on pathways away from the waters edge. This design would allow for easier egress for canoeists so that they can get out of the river upstream and portage around the weir. There would still be a fence and the main walkway would be back from the river for those who do not want to expose themselves to the river and those that do make a conscious decision to do so by going to the stepped area aware of the hazard. This version would allow emergency and rescue service vehicles and watercraft to access the stepped area.
