### Landscape Design Roxby Community Garden, Lincoln Green

1:150 @ A3

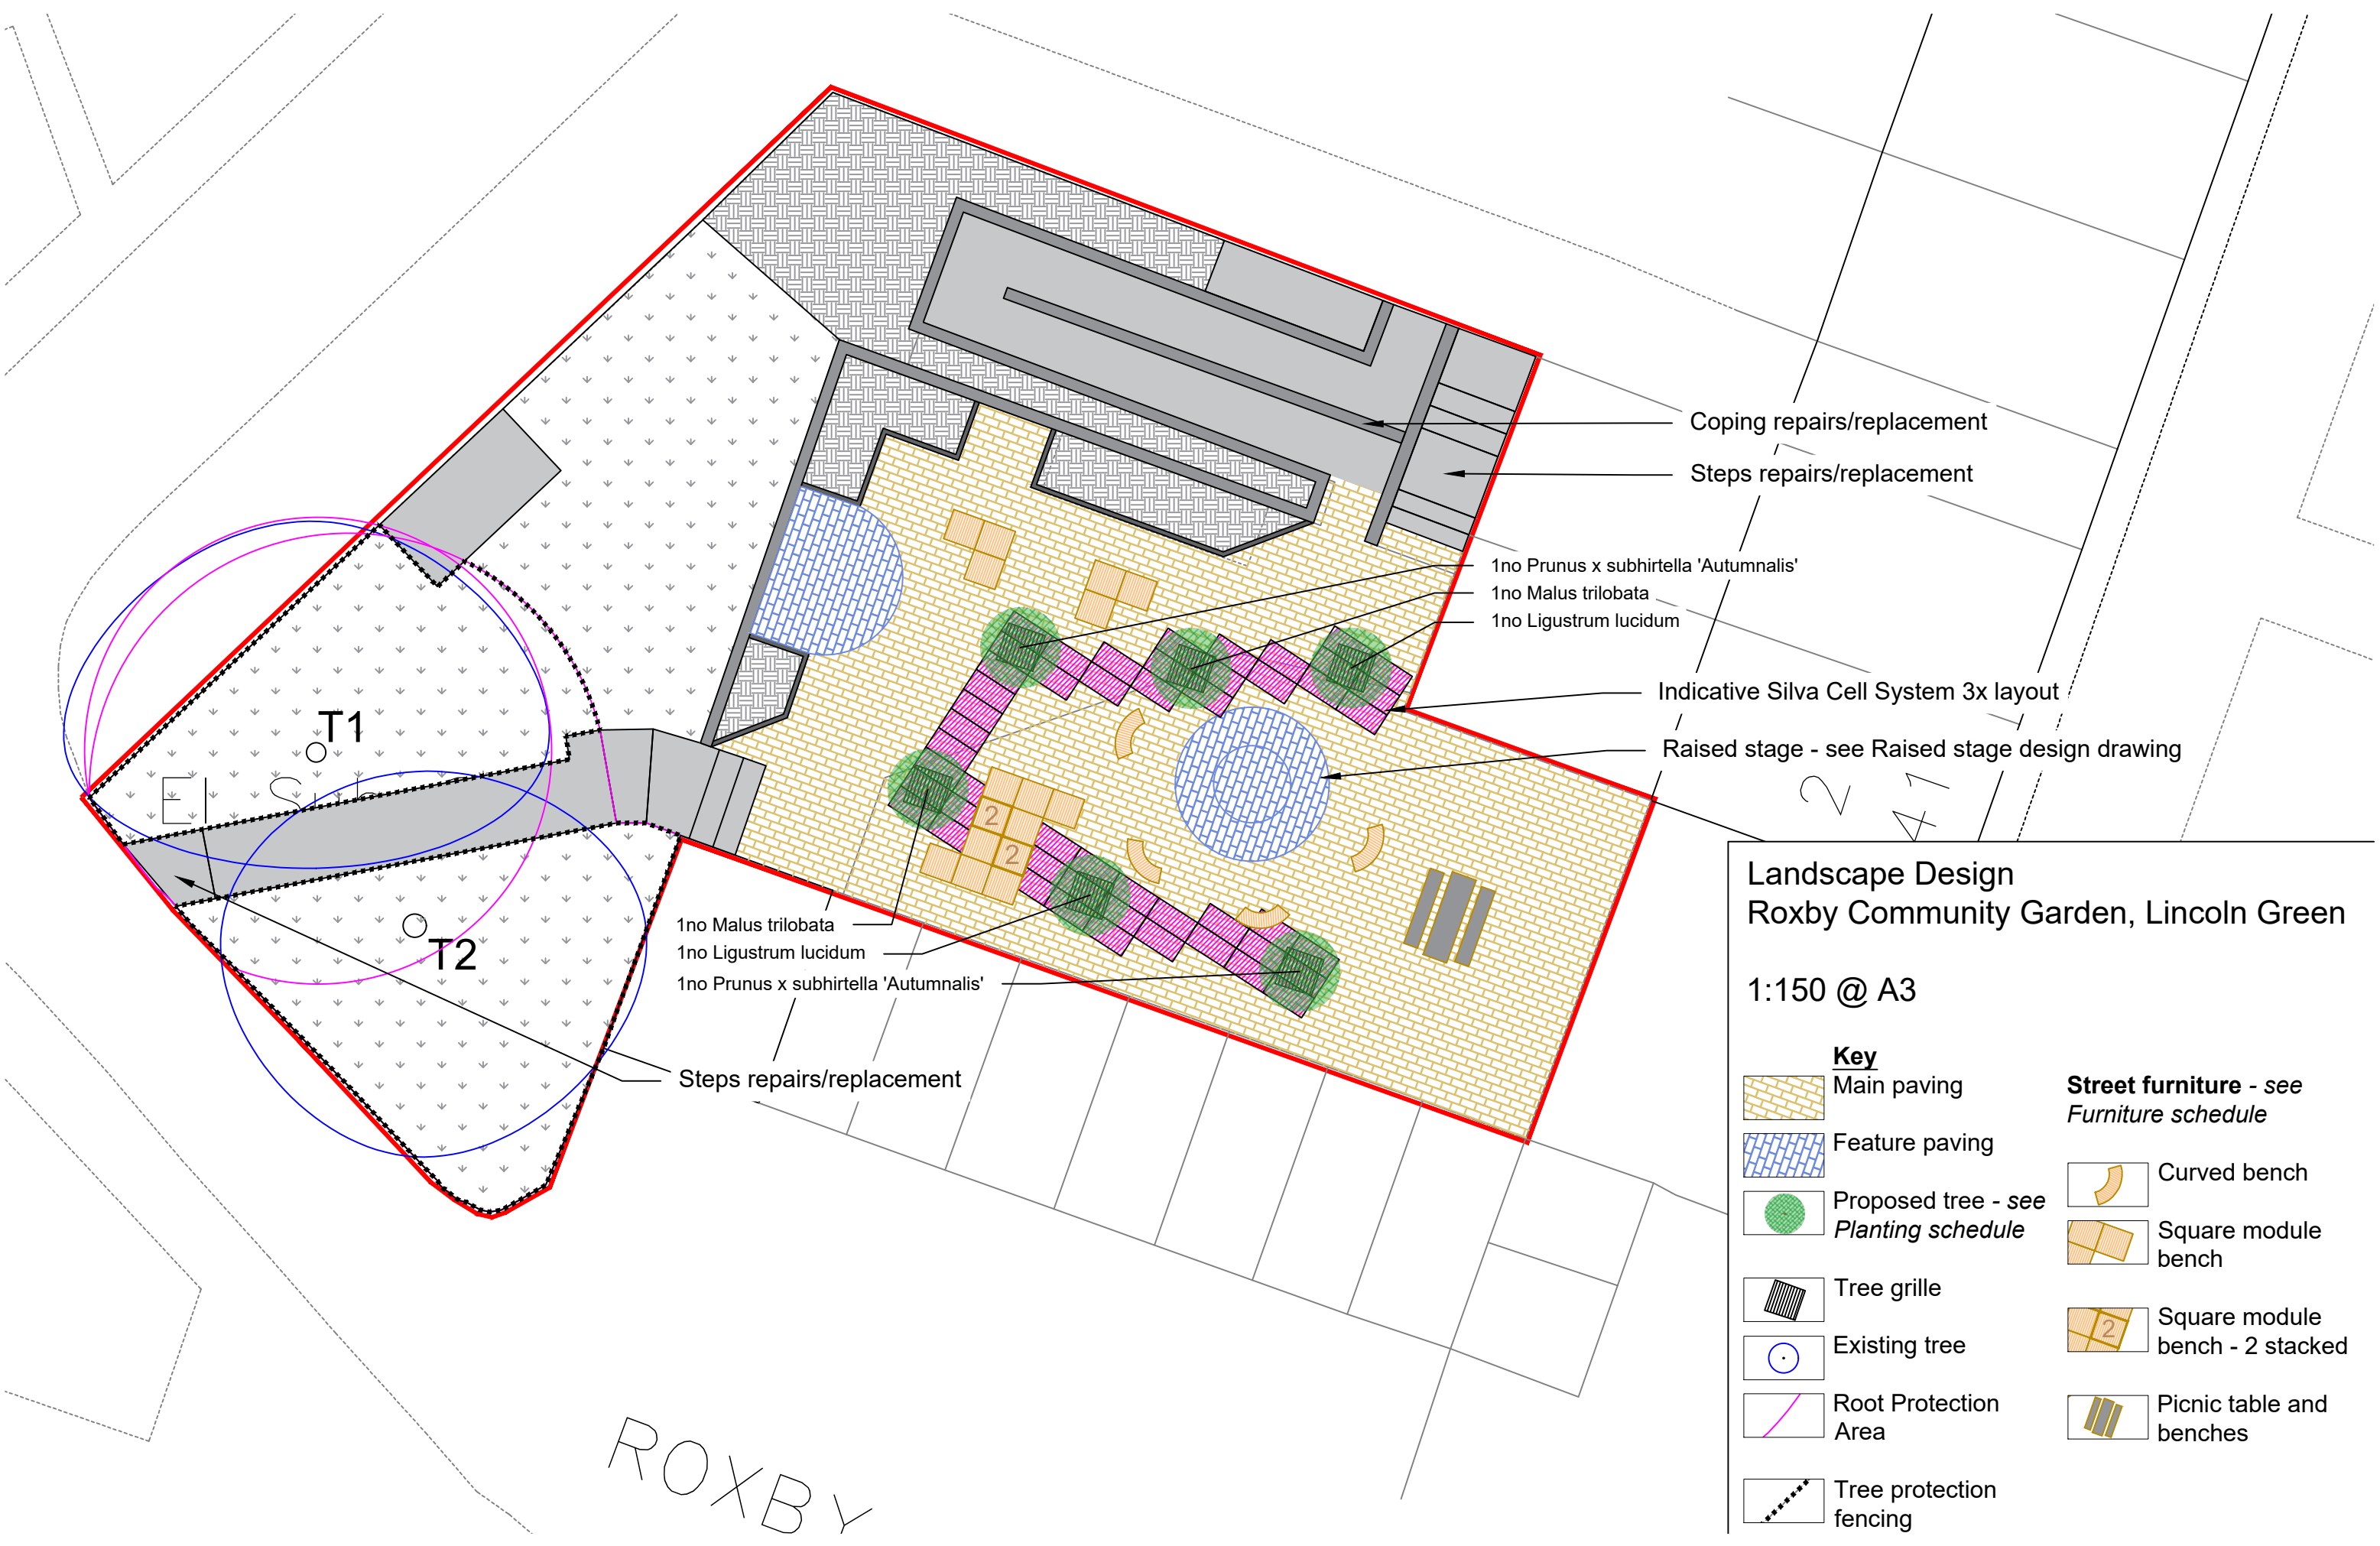
Coping repairs/replacement

Steps repairs/replacement

1no Prunus x subhirtella 'Autumnalis'

1no Malus trilobata

1no Ligustrum lucidum

Indicative Silva Cell System 3x layout

Raised stage - see Raised stage design drawing
